MOOI MGENI TRANSFER SCHEME PHASE 2 (MMTS-2) Construction of the Spring Grove Dam Wall

MONTHLY ECO REPORT : November – December 2011

Report Title: **Monthly Environmental Control Officer Report**

Date of issue: **13 December 2011**

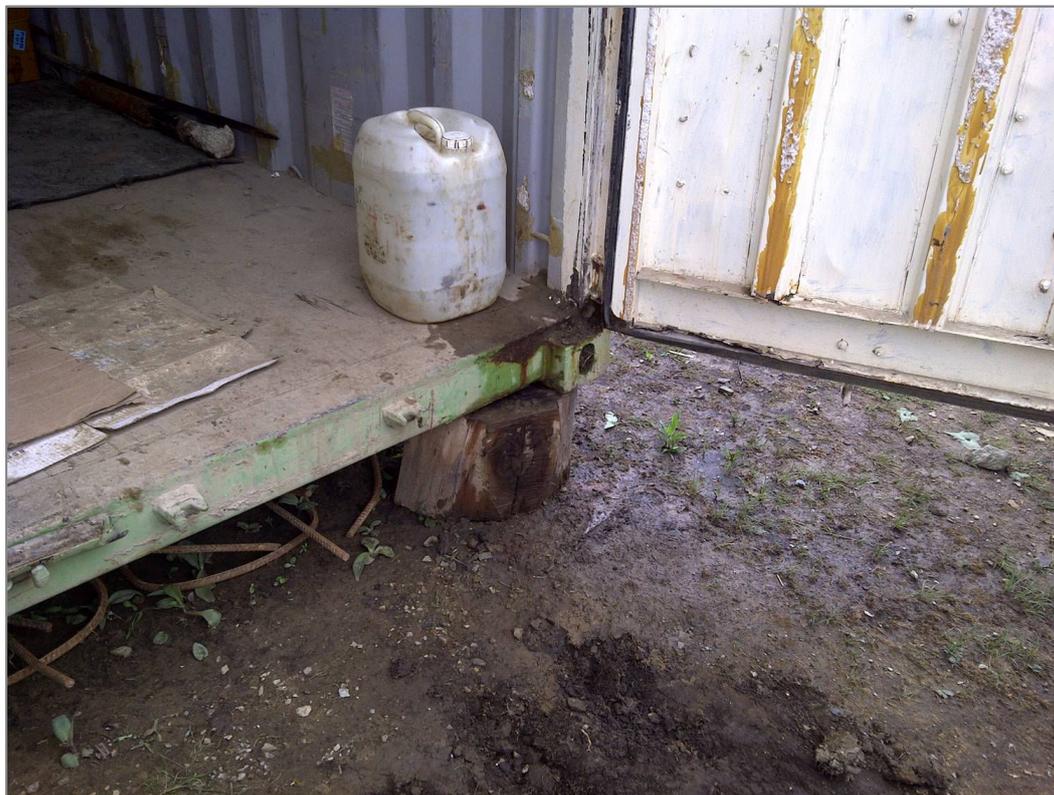
Figure 9: Improved handling and storage required for antifreeze container

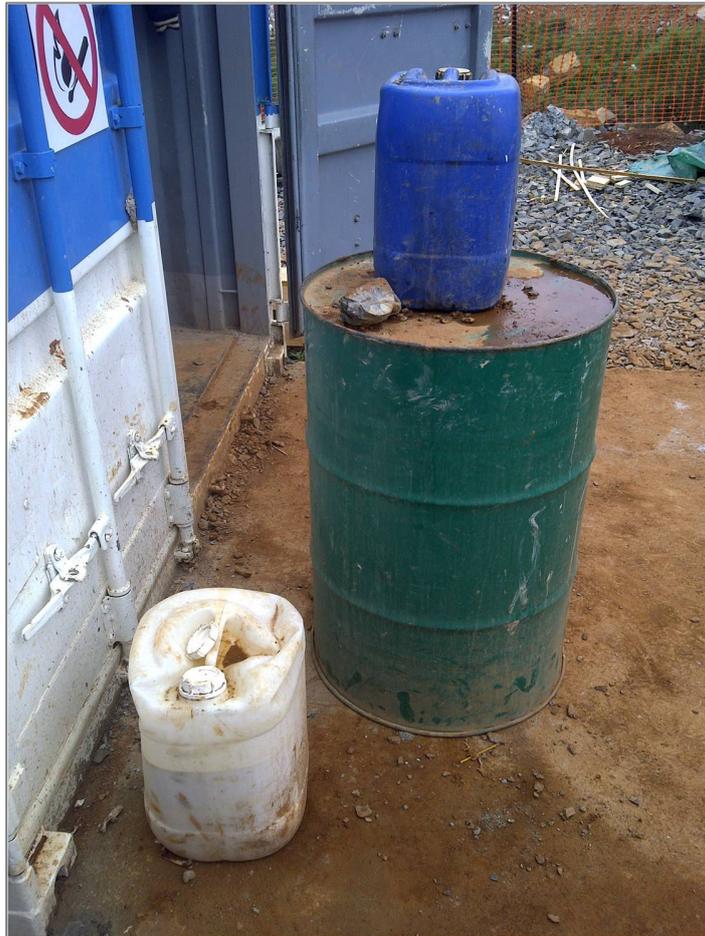
Figure 10: Containers for hazardous materials to be labelled
