MOOI MGENI TRANSFER SCHEME PHASE 2 (MMTS-2) Construction of the Spring Grove Dam Wall

MONTHLY ECO REPORT : October – November 2011

Report Title: **Monthly Environmental Control Officer Report**

Compliance Report No: **08**

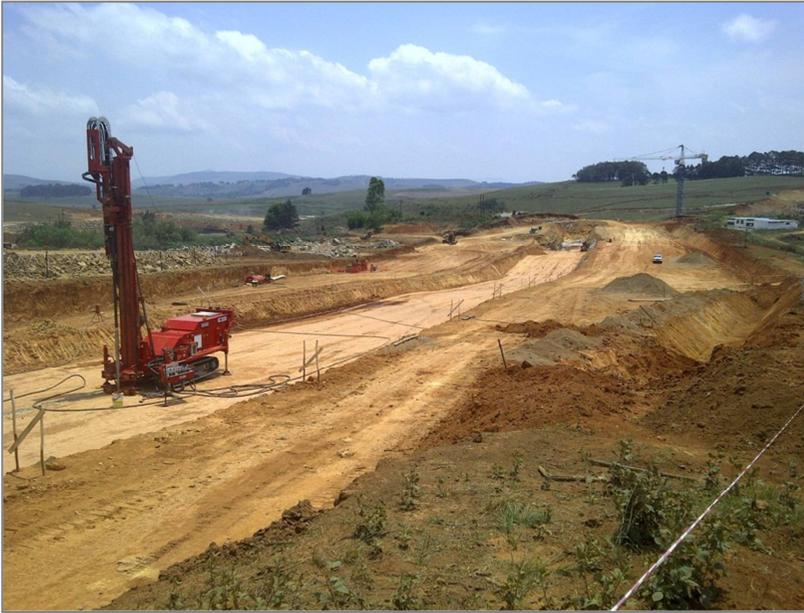
Figure 2: Construction of earth embankment

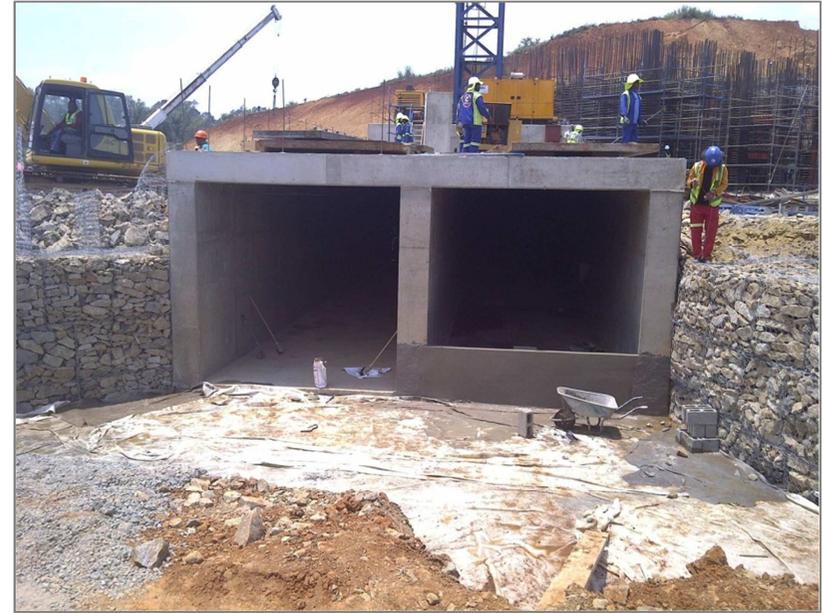
Figure 4: Construction of the river diversion

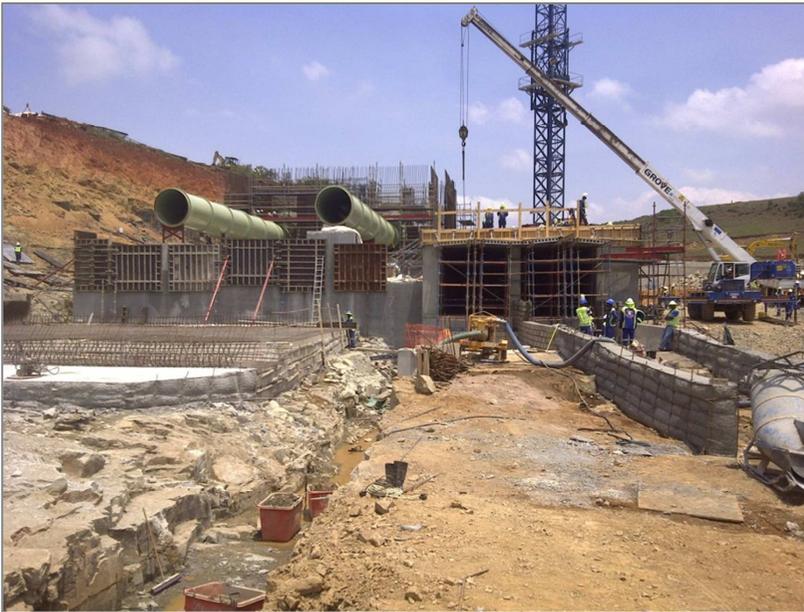
Figure 3: Construction of conduit and outlet works

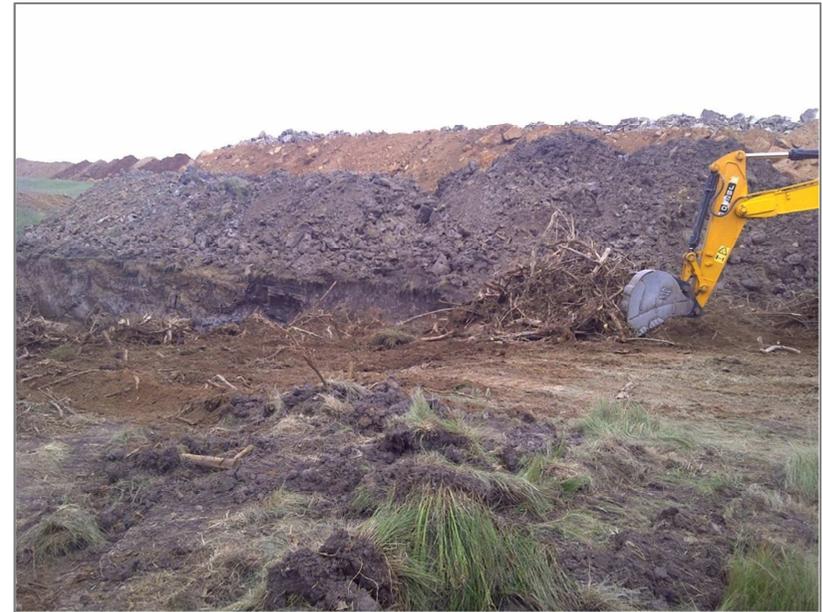
Figure 5: Burying of plant material

075	Sensitive environmental feature	<ol style="list-style-type: none"> 1. The location of the excavation for the burial of vegetation removed from site is inadequate, as this area is a wetland which is a sensitive environmental feature. 	<ol style="list-style-type: none"> 1. Consultation with the environmental team on site should have been undertaken in order to identify a suitable area for burial of the vegetation removed from the site.
076	Housekeeping	<ol style="list-style-type: none"> 1. Housekeeping at the workshop area. 	<ol style="list-style-type: none"> 1. Housekeeping to be addressed. EM suggested deadline: 24 November 2011.
077	Waste Separation	<ol style="list-style-type: none"> 1. Waste separation at the waste transition area. 	<ol style="list-style-type: none"> 1. Waste separation to be addressed. EM suggested deadline: 24 November 2011.

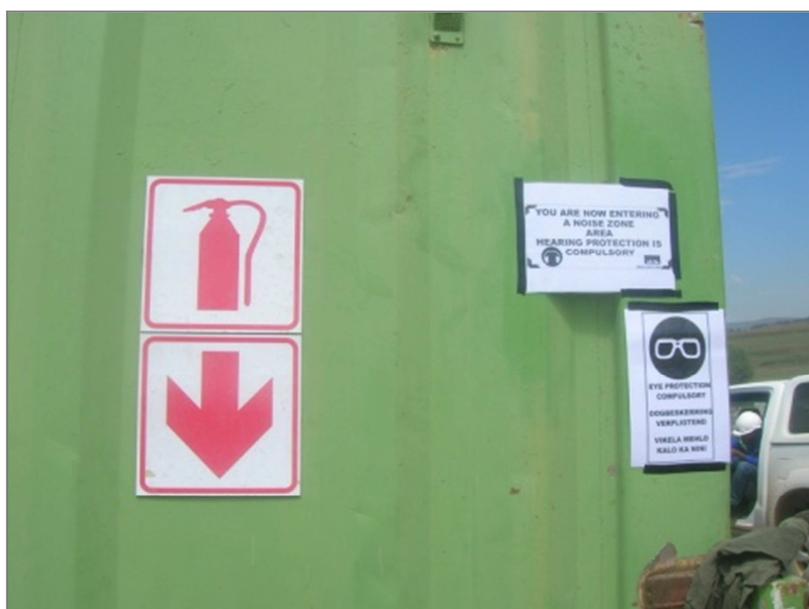
Figure 6: Signage for storage of hazardous material at crusher area

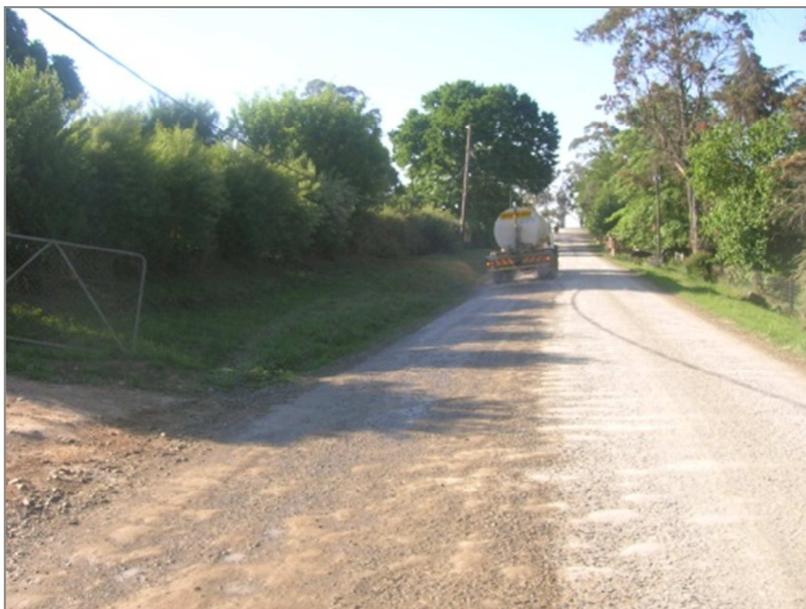
Figure 7: Dust abatement on Overdale Road

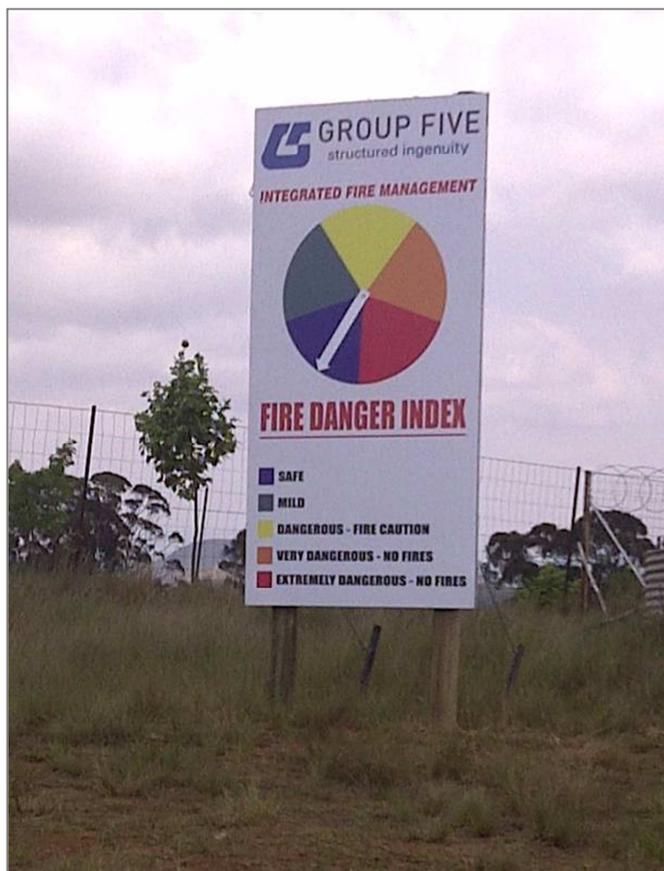
Figure 8: Fire Danger Index signage erected adjacent to the site entrance

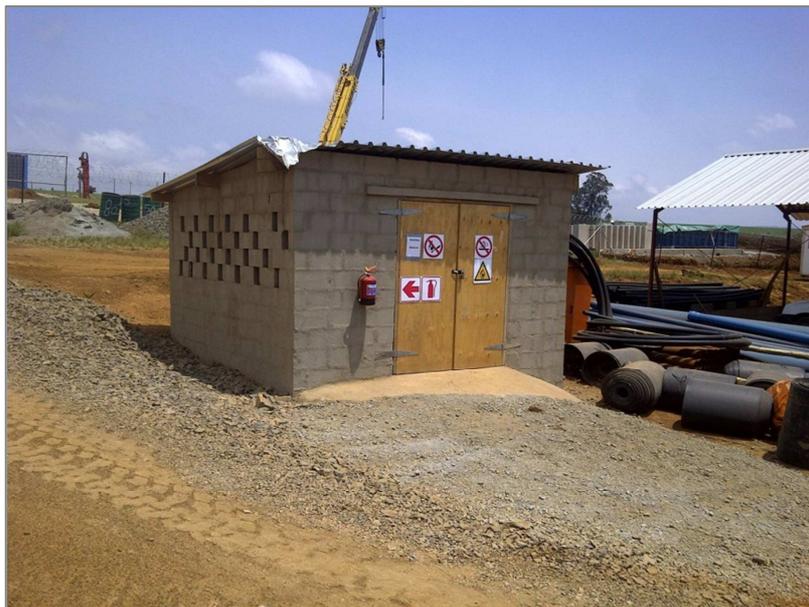
Figure 9: Designated area for storage of hazardous material

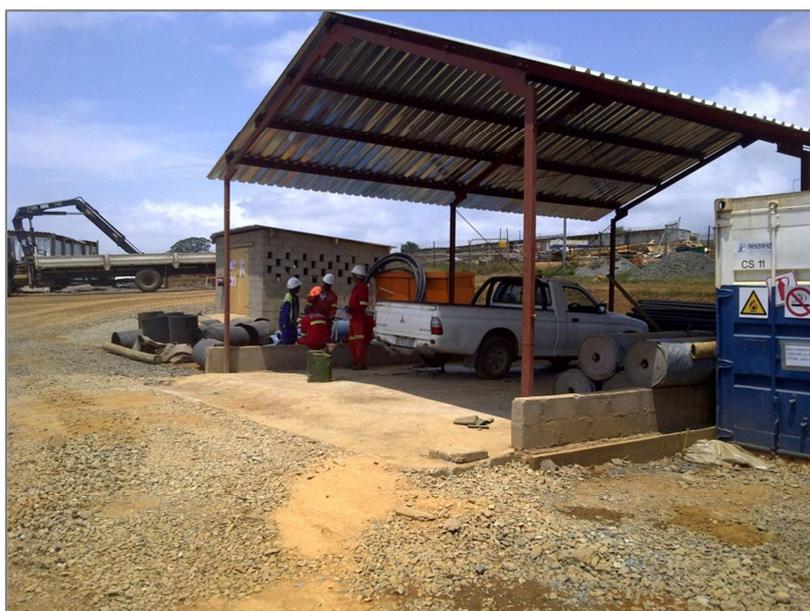
Figure 10: Servicing of vehicle in designated area

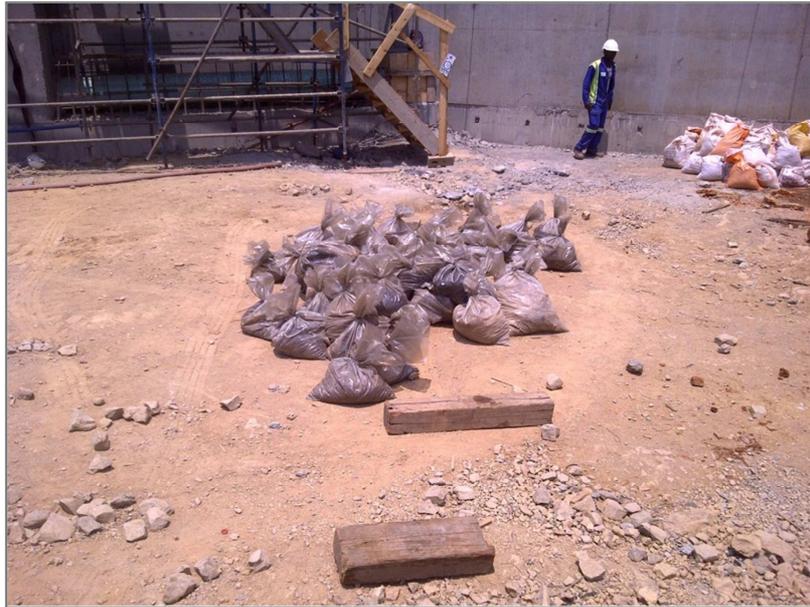
Figure 11: Clean-up of spillage

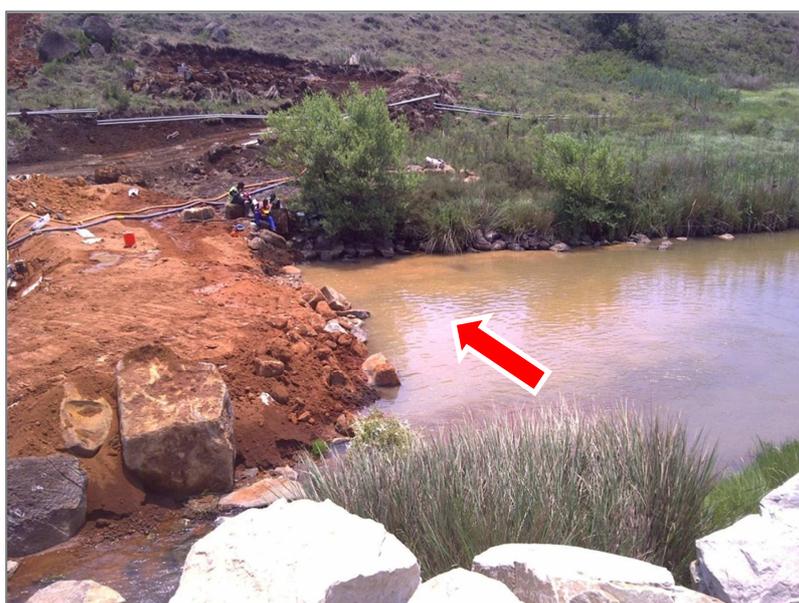
Figure 12: Siltation of the river

Date of NCR / Incident	Description	Suggested Corrective Action	Actual Corrective Action	EM Suggested Deadline	Actual Date Corrected	Closed-Out
16/11/2011	Silt laden water was observed entering the river from dewatering practices at the dam foundation area. On the 15/11/2011 this activity was stopped by the RE; and suitable measures were asked to be put in place before the activity resumed. Upon inspection by the EM on the 16/11/2011 the measures in place were observed to be inadequate, resulting in sedimentation of the river. This issue is also on the EM's action register from the 09/11/2011 for action.	The contractor must take cognisance of section P67 4.3.6 (a) and (b) and to ensure that adequate measures are in place when undertaking dewatering practices.		12/11/2011		No
