MOOI MGENI TRANSFER SCHEME PHASE 2 (MMTS-2)

Construction of the Spring Grove Dam & Appurtenant Works

MONTHLY ECO REPORT : September 2012

Report Title: **Monthly Environmental Control Officer Report**

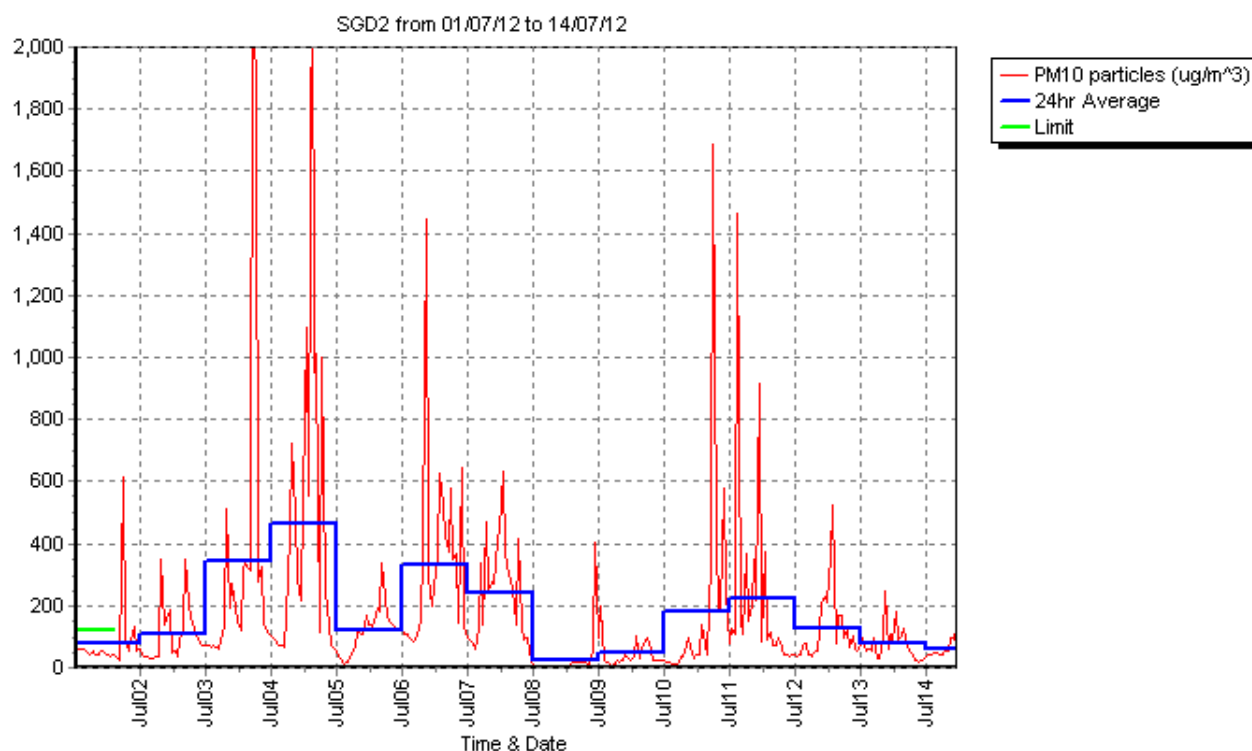
Figure 15: PM₁₀ concentrations for July 2012 (Blue Sands, 2012a)

- During July 2012, the PM₁₀ concentrations exceeded the 24-hour limit of 120 µg/m³ for 7 of the 14 days measured. The top ranked exceedences are examined in the table to follow.

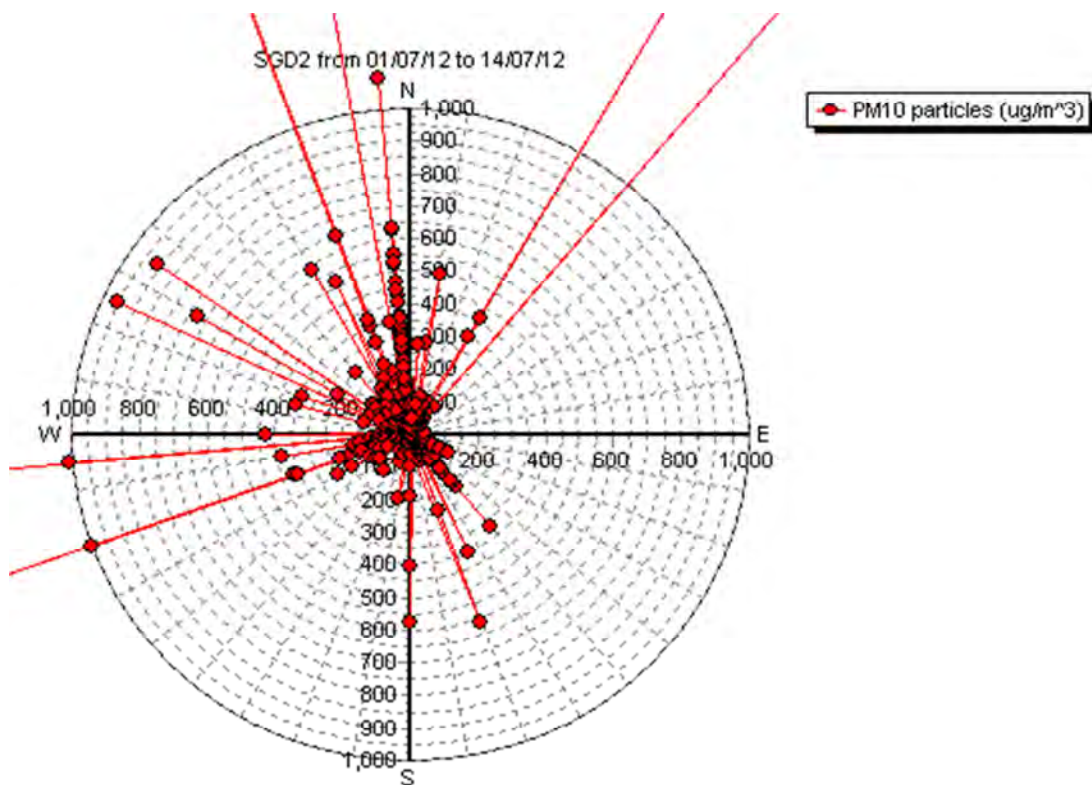
Figure 16: 1-hour PM₁₀ pollution rose for July 2012 at site SG01 (Blue Sands, 2012a)

- The pollution rose (see **Figure 16**) shows that the major contribution to the dust levels recorded came from the north-westerly sector – caused by the Berg winds. There are two sources in this area; one being the aggregate stockpile and the other being the parking area for the office block. Another source emanates from the south-west, which relates to hauling and activities at the dam wall.

- Blue Sands (2012a) recommended that Afrisam needs to control emissions from the aggregate piles over the next few months, during which time Berg Winds from the north to northwest will tend to exacerbate this particular source.

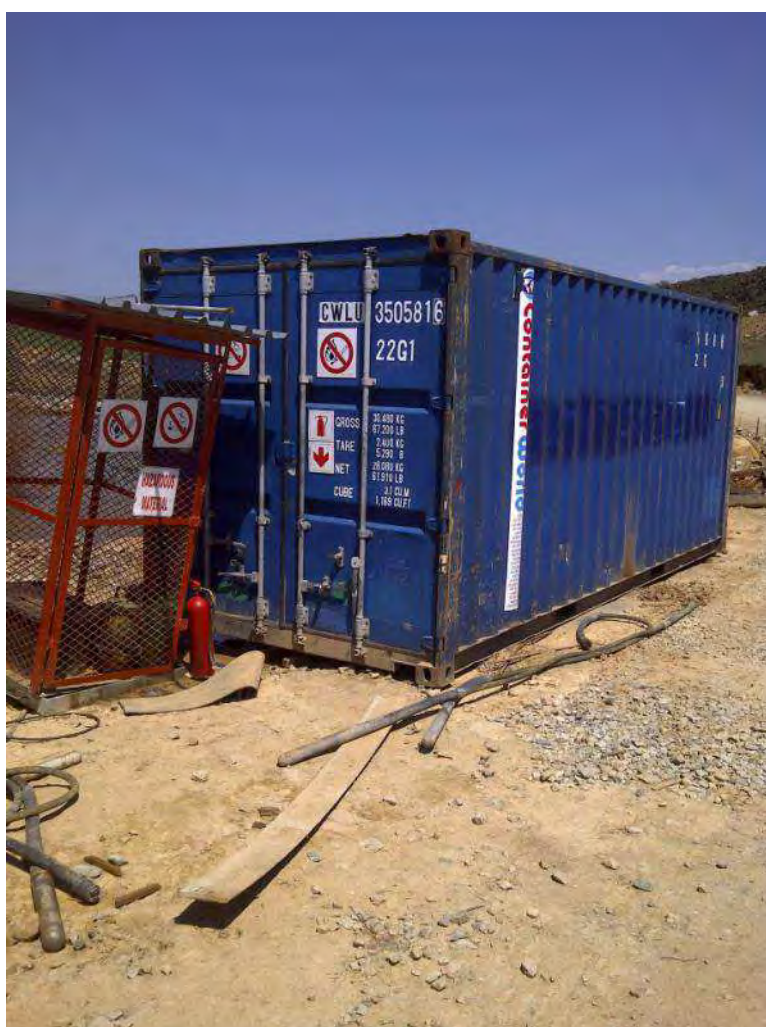
Provisions of the Hazardous Substances Act (Act 15 of 1973) to be adhered to	
Materials	Spill reporting procedures to be posted at all storage facilities so that the appropriate emergency response can be mobilised in the event of a spill	Additional signage required for all relevant storage areas.
	In the case of a spill, immediate action must be taken to stop and contain the spill. Any observed spills / leakages must be removed and the cause remedied.	Improved turn-around period required for remediating spills. Leaking secondary container at Rodio equipment (Figure 18).
	A record of all types and quantities of hazardous materials on site to be kept	Hazardous material register available, which records fuel. Needs to include hazardous material in containers.
	Flammable liquid stores to be well ventilated and free of explosive vapours	Strong odour detected at container on left bank - complaint received from labourer regarding fumes (Figure 17).

Figure 17: No ventilation of container used for storage of hazardous material

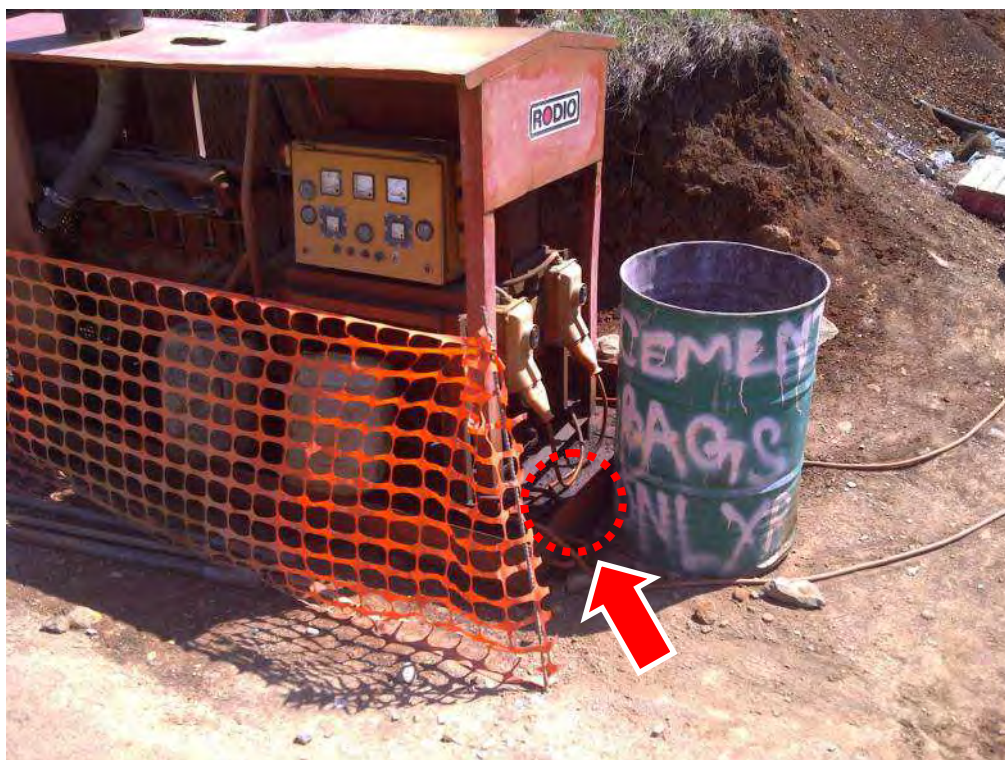
Figure 18: Leaking secondary container

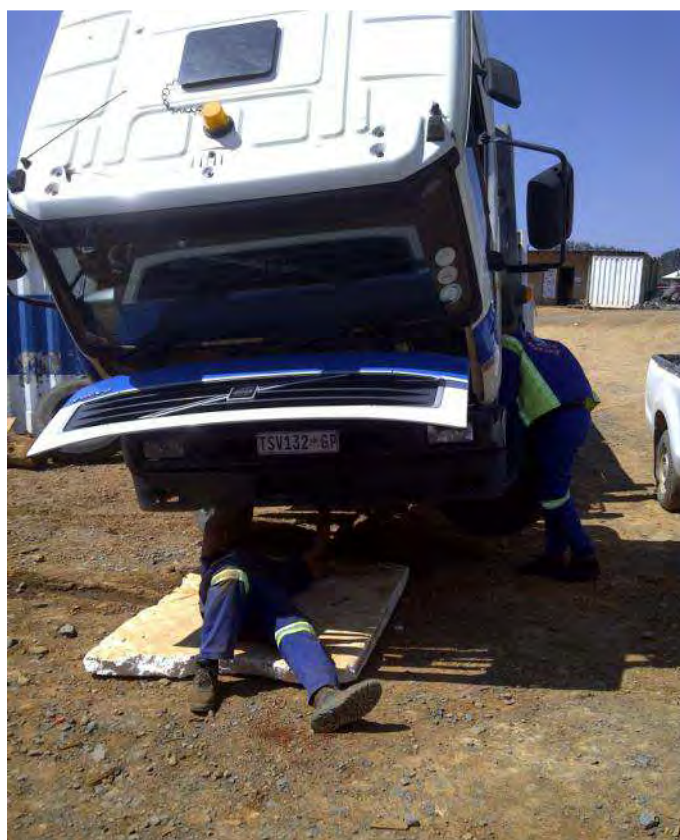
Figure 19: Vehicle maintenance outside designated area

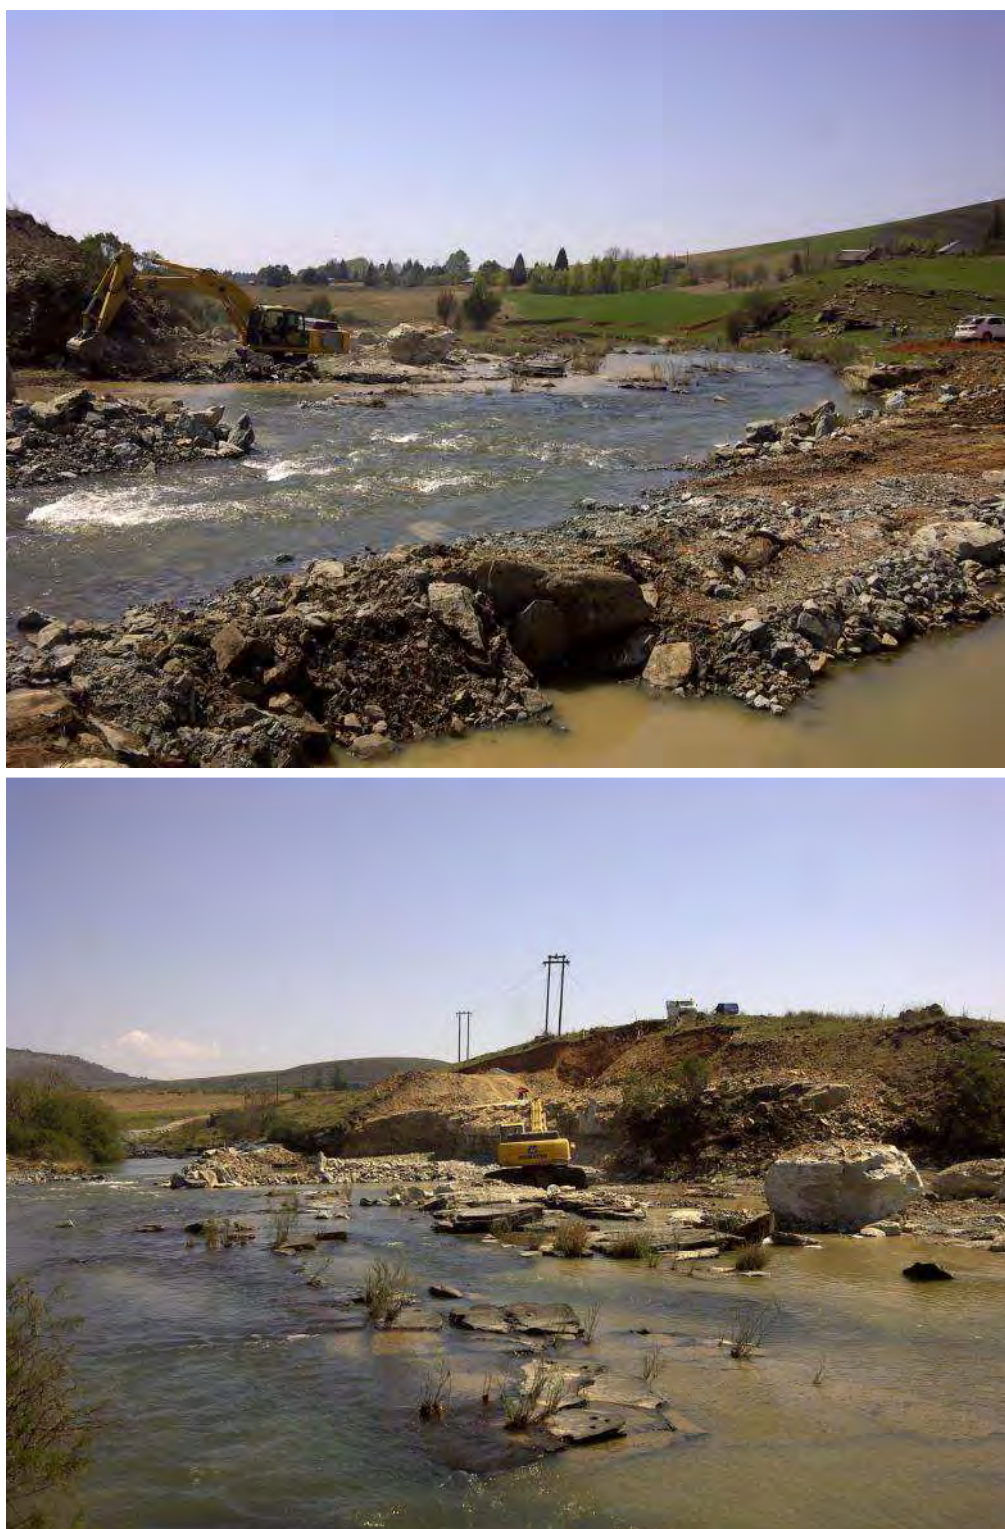
Smoking is prohibited in fire hazard areas (i.e. workshops, fuel storage areas)	Sigarette butts found immediately adjacent to hazardous storage containers.
Water Quality	Provide treatment and/or disposal method for the wastewater	Vehicle maintenance outside designated area (Figure 19).
	Silt laden water shall not be directly discharged over land or directly into watercourses and shall be	<ul style="list-style-type: none"> No provision for management of siltation at fish barrier instream works (Figure 20).

Figure 20: No provision for management of siltation at fish barrier instream works

A more pro-active approach is required to environmental management on the site. This is particularly relevant to sediment management at instream works, where the sediment caused by construction activities should not be left to be assimilated by the watercourse without appropriate mitigation.

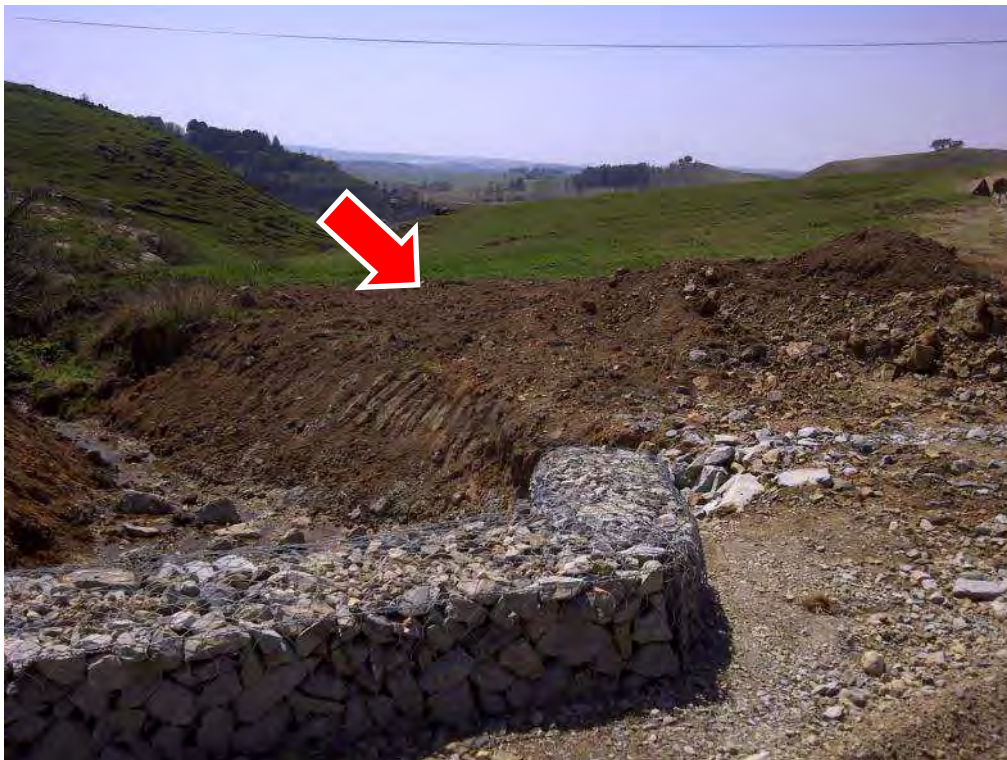
Figure 21: Stockpiling of soil on stream bank

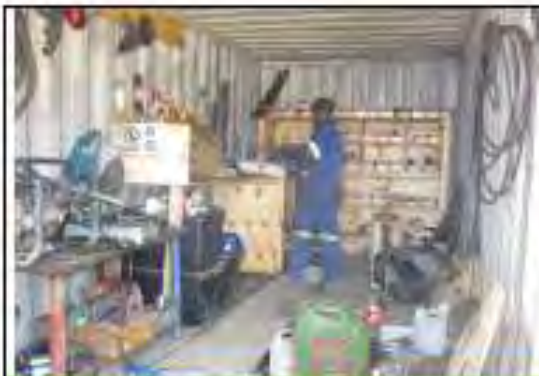
Fig. 7: On 20 September 2012 (date of last weekly inspection), a work area has been placed inside a storage container on the left bank that also houses diesel powered equipment and hazardous storage containers.

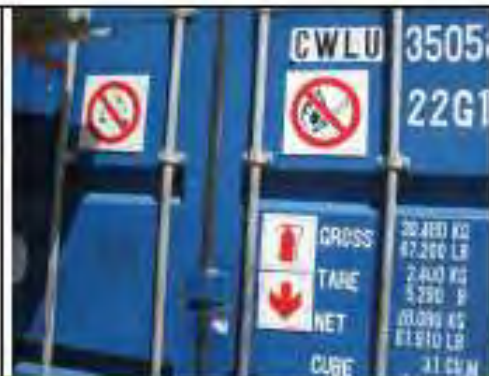
Fig. 8: During this inspection, this storage container was locked and not inspected.

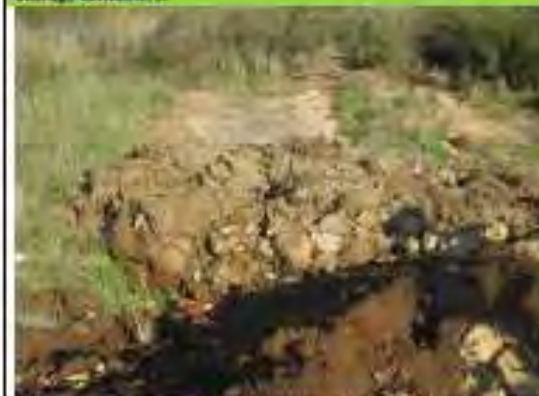
Fig. 9: On 20 September 2012 (date of last weekly inspection), a geotextile sock at the Spring Grove Weir has been removed and what appears to have been its contents remain adjacent to the river.

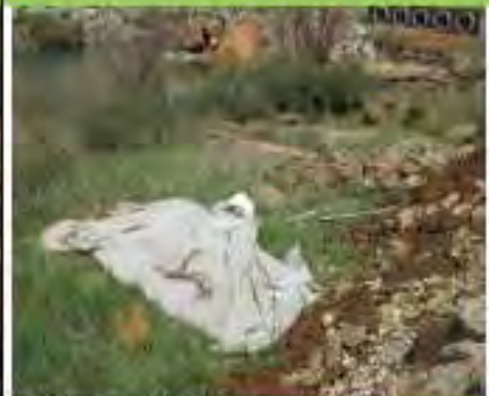
Fig. 10: During this inspection, sediment removed from a geotextile sock remain (background), alongside a discarded geotextile sock at the Spring Grove Weir construction site.

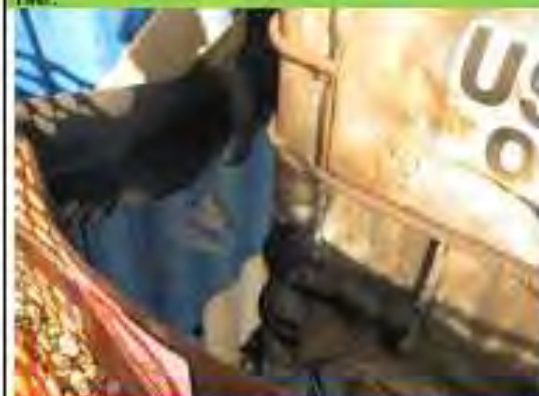
Fig. 11: On 20 September 2012 (date of last weekly inspection), a large amount of used oil wax present in outdoor storage container at the workshop.

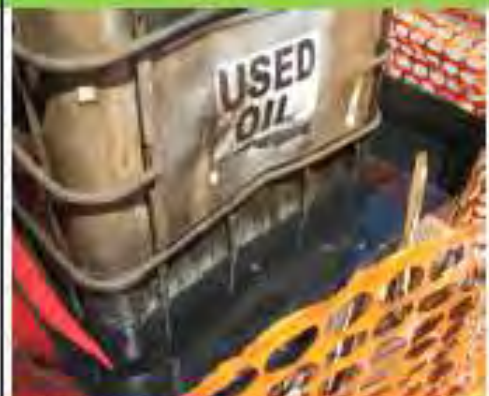
Fig. 12: During this inspection, the amount of used oil in this container at the workshop remained unchanged.

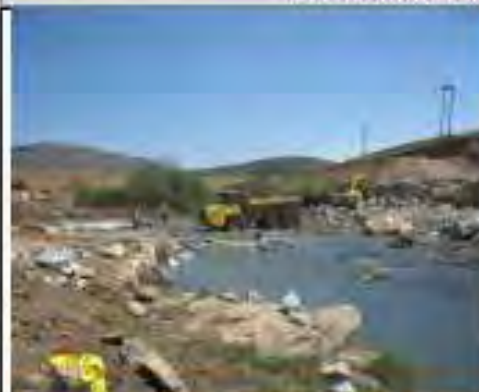
Fig. 3: Equipment crossing the Most River causing sediment to be discharged at the river diversion (fish barrier).

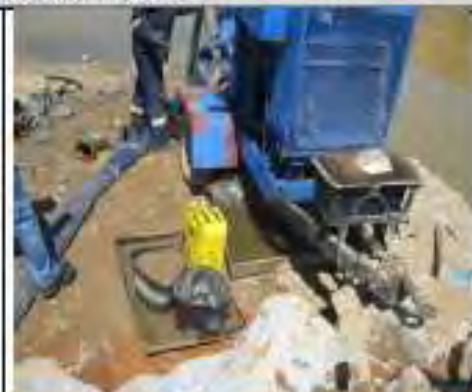
Fig. 4: Close-to-overflowing drip trays under diesel-powered equipment and hazardous storage container at the river diversion (fish barrier).

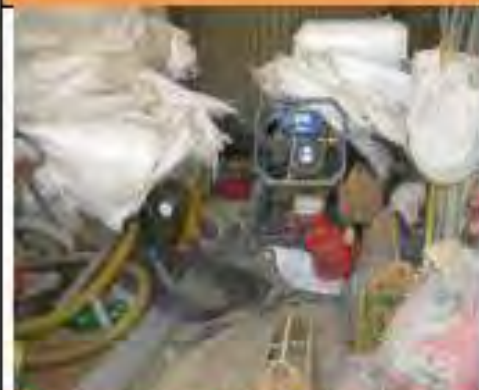
Fig. 5: Lack of drip trays under diesel powered equipment and hazardous storage container. Also, poor housekeeping in container at the Spring Grove weir.

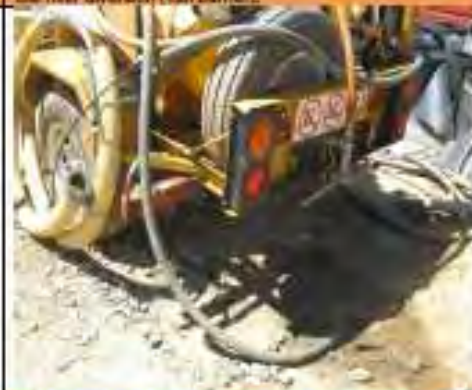
Fig. 6: Lack of proper bunding under parked diesel bowser at left bank.
