MOOI MGENI TRANSFER SCHEME PHASE 2 (MMTS-2) Construction of the Spring Grove Dam Wall

MONTHLY ECO REPORT : September – October 2011

Report Title: **Monthly Environmental Control Officer Report**

Compliance Report No: **07**

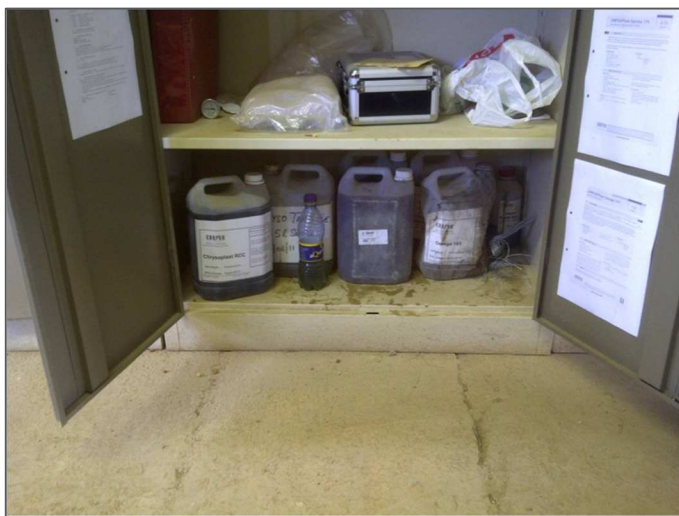
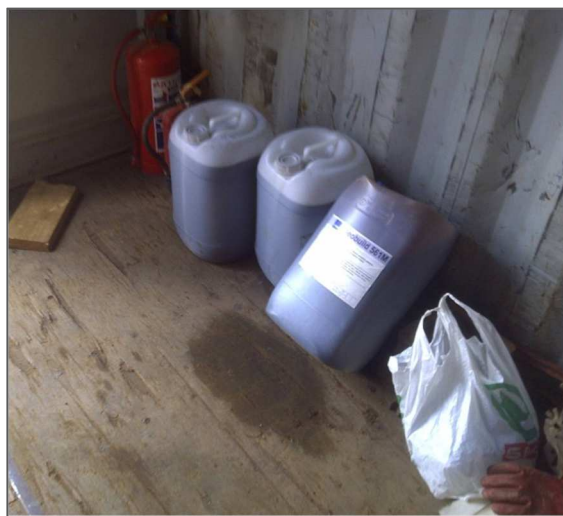
**Figure 13: Inadequate storage of hazardous material – area not bunded**

| Condition / Mitigation Measure | Comments |
|---|---|
| The hazardous storage area to be bunded with approved impermeable liner. The bund wall must cater 110% of the volume of the storage container | Dedicated storage area for hazardous material currently being built. Improved storage required for hazardous material at laboratory and in containers. See Figure 13 . |

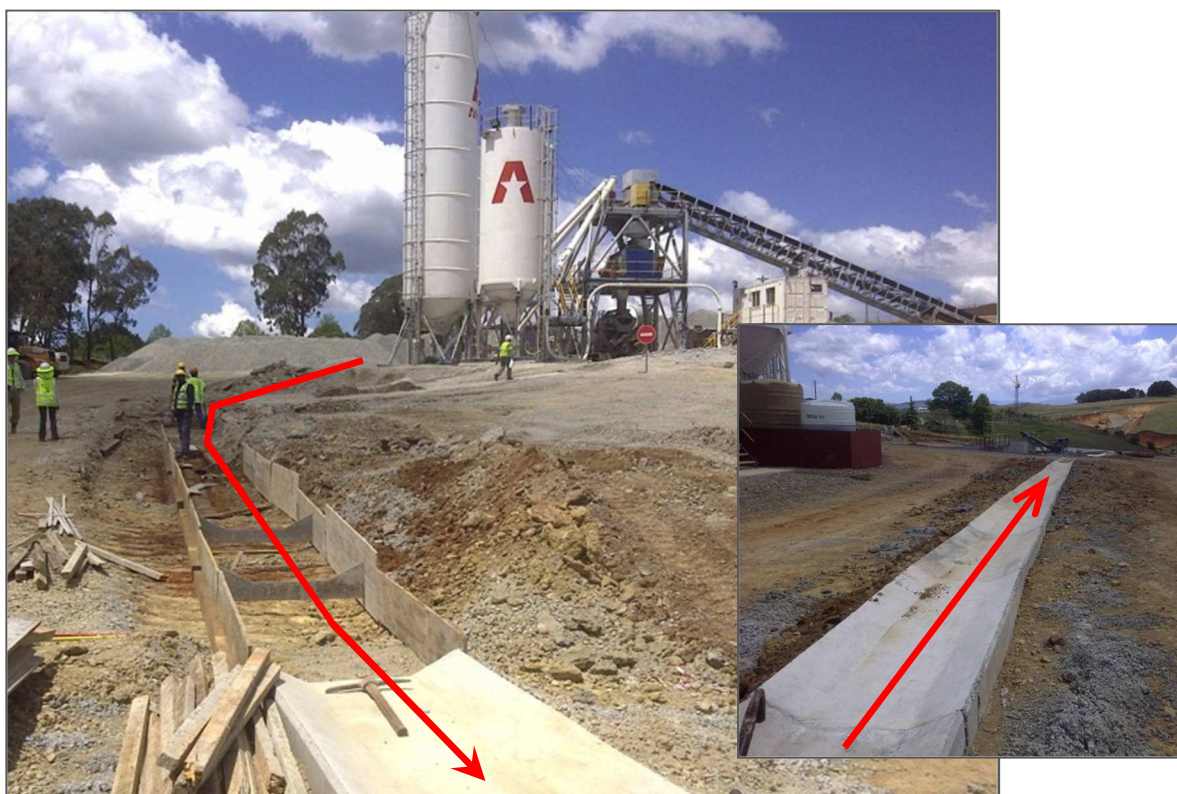
Figure 14: Intervention underway to manage wastewater at batch plant

| Issue Ref. | Category | Observations | Improvements Required / Objectives to be achieved |
|---|---|---|---|
| | | 5. Wastewater observed at the batch plant area. | 5. Water management at the batch plant area to be undertaken. |

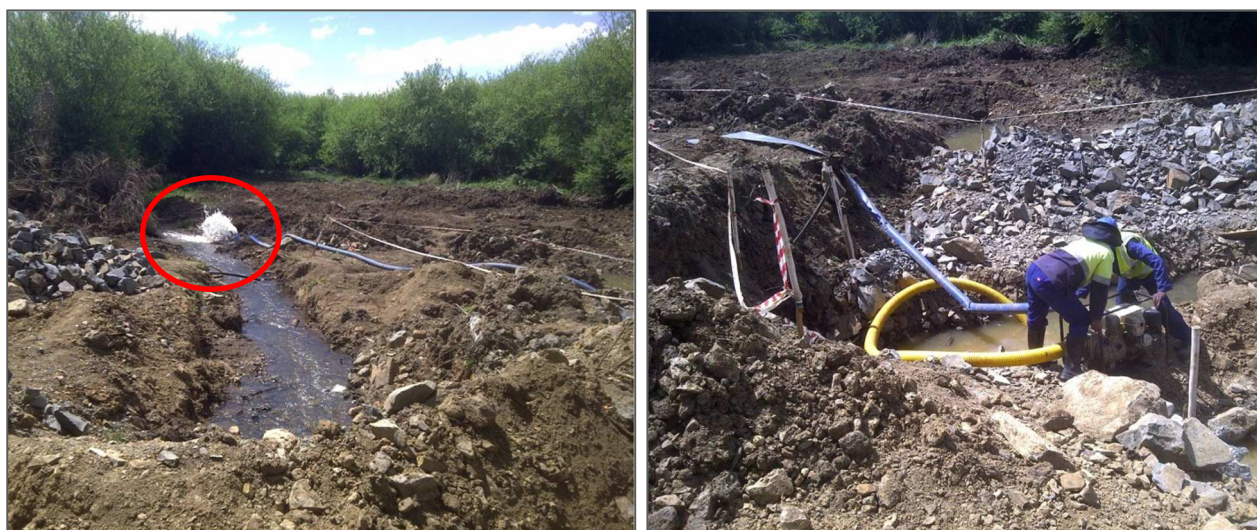
Figure 15: Sedimentation at the watercourse crossing on the D146

| Condition / Mitigation Measure | Comments |
|---|---|
| Such overland discharge may not cause erosion | Scouring at release point of water pumped from excavation at D146 watercourse crossing. |

| Date of NCR / Incident | Description | Suggested Corrective Action | Actual Corrective Action | EM Suggested Deadline | Actual Date Corrected | Closed-Out |
|---|---|--|--|---|---|---|
| 17/10/11 | Due to excavation/placement of materials in the second coffer dam, a large amount of silt laden water was observed entering the river. The measures in place failed to prevent sedimentation. Additionally the silt curtain proved to be ineffective as silt laden water was observed further downstream. This is in contravention of P67 4.3.6 of the specification. | The contractor is requested to provide feedback on how such occurrences will be dealt with in future. | 18/10/2011: Feedback received from contractor highlighting measures to be undertaken before future activities of this nature occur. (Email filed in J00846-9.7.General and as attachment to NCR 09 in J00846-2.1) | 18/10/2011 | | YES |

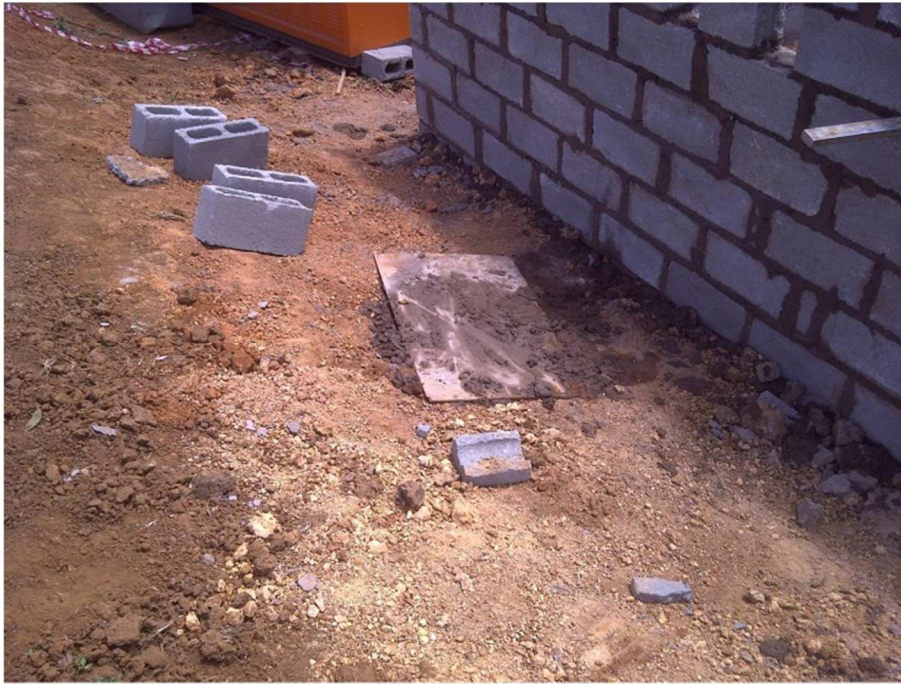
Figure 16: Cement mixing to take place on an impermeable surface

| Condition / Mitigation Measure | Comments |
|---|---|
| Site to be kept clean and free of litter | Cement mixing to take place on an impermeable surface. See Figure 16 . |
