## MOOI MGENI TRANSFER SCHEME PHASE 2 (MMTS-2) Construction of the Spring Grove Dam & Appurtenant Works

[DEA Reference Number: 12/12/20/220]

### MONTHLY ECO REPORT : February 2015

*Report Title:* **Monthly Environmental Control Officer Report**

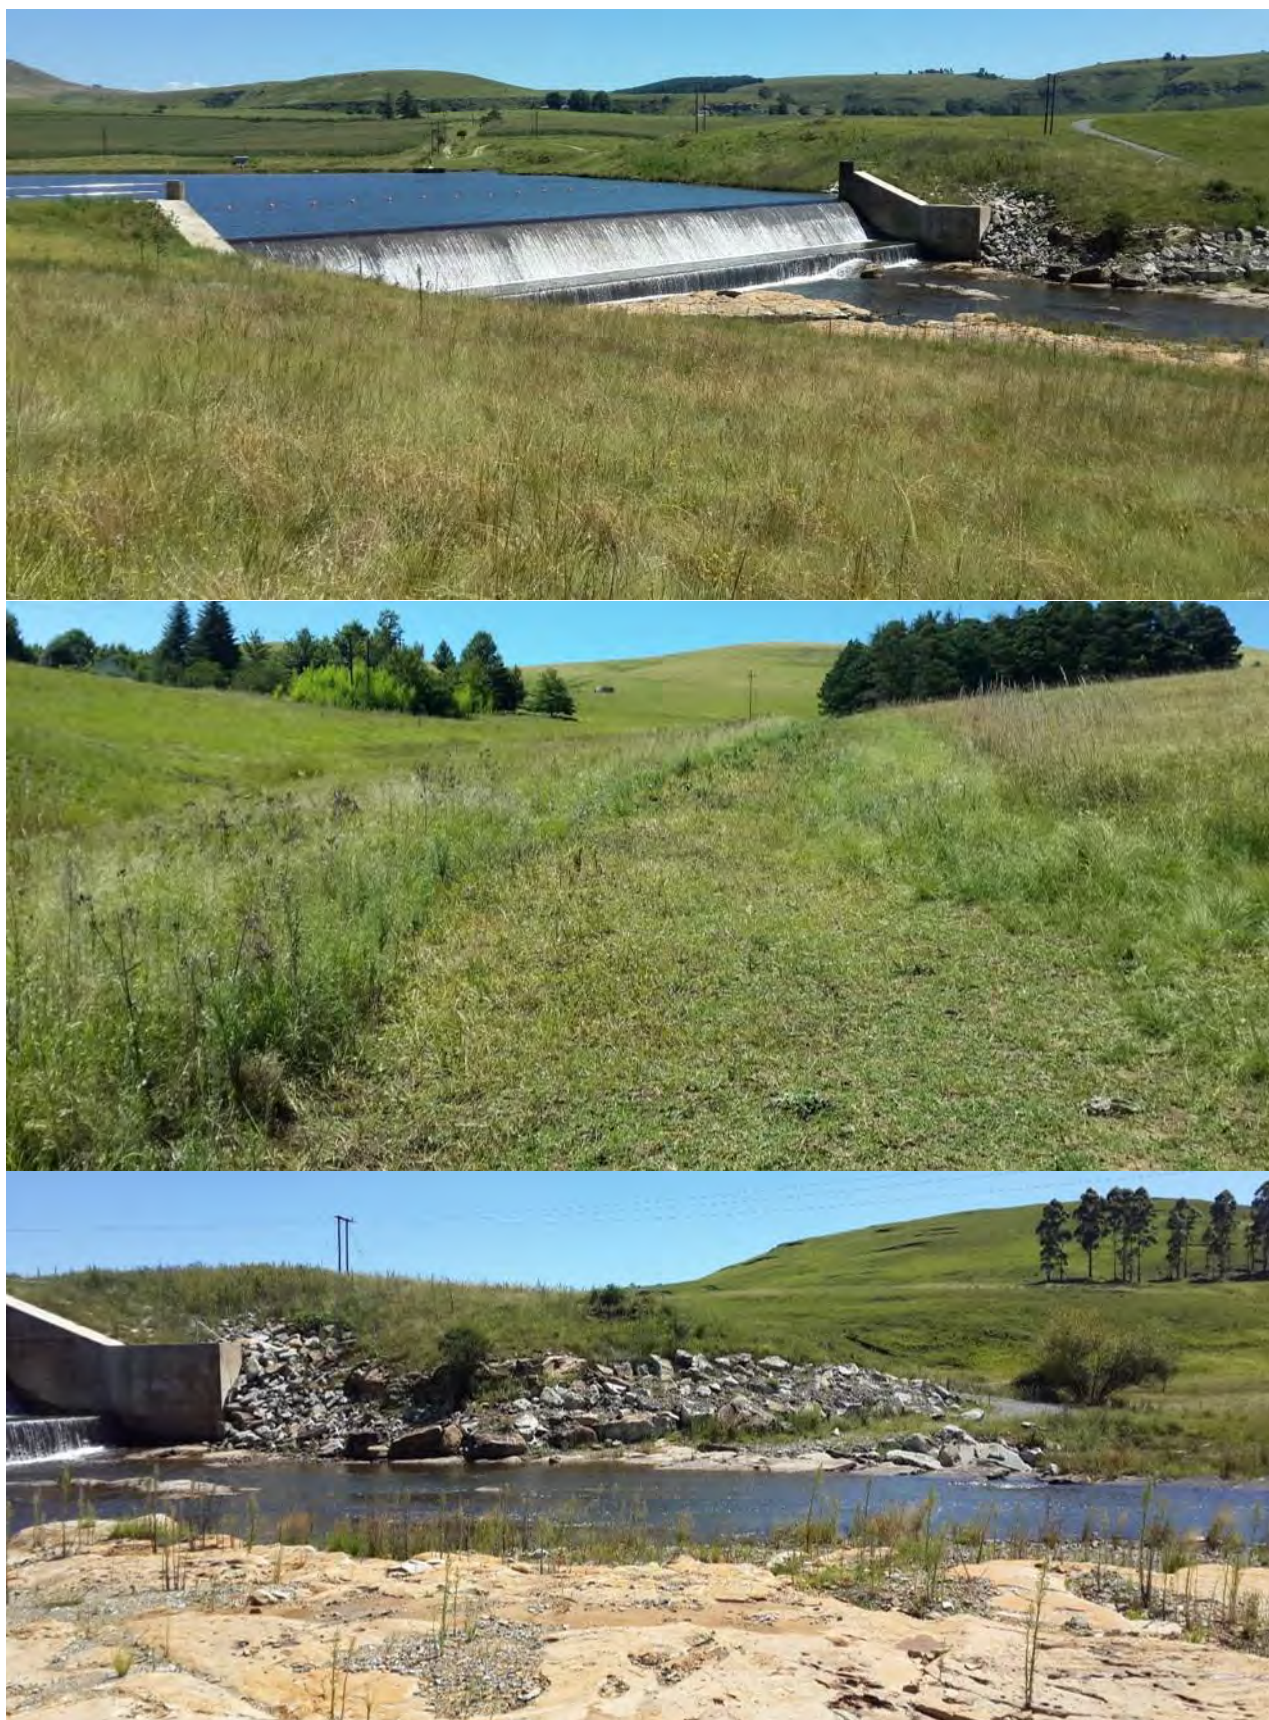
**Figure 7:** Fish barrier (top – general view; middle – access road ; bottom – left bank)

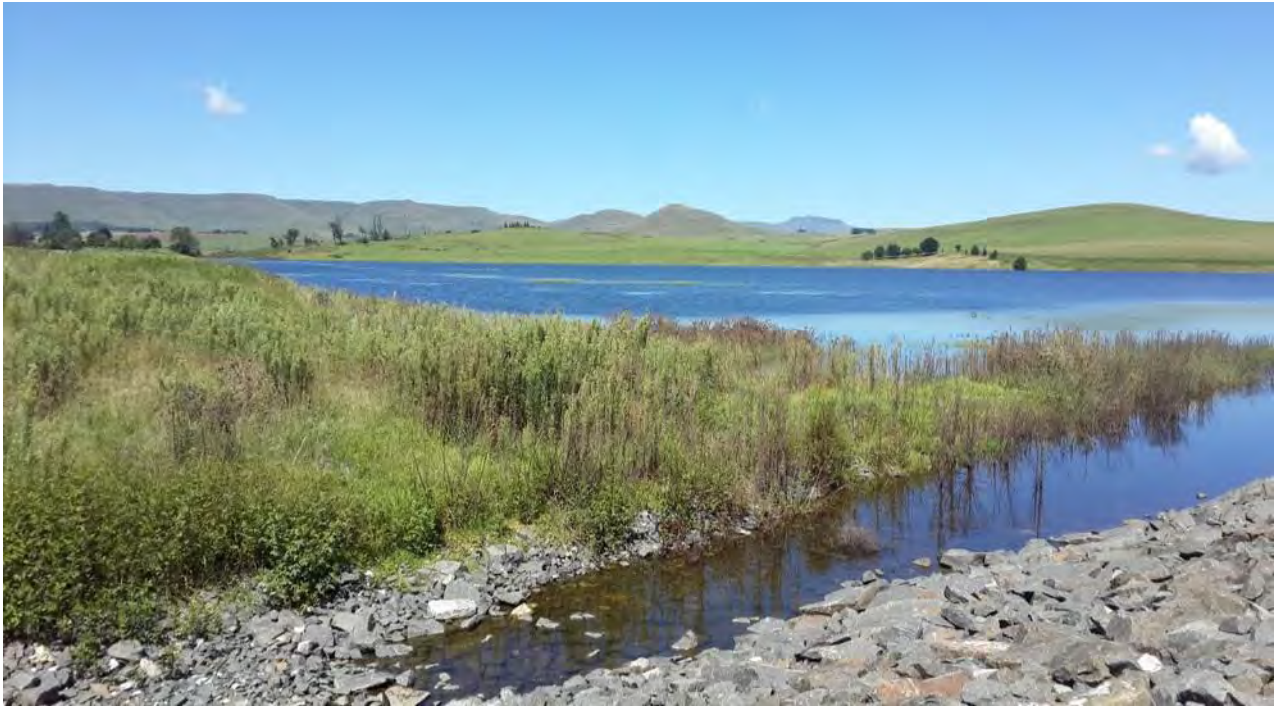
- General management of alien invasive plant species and weeds within shoreline area of state land (see example shown in **Figure 12**). It is acknowledged that this function forms part of the dam operator's duties.

**Figure 12:** Weeds along shoreline

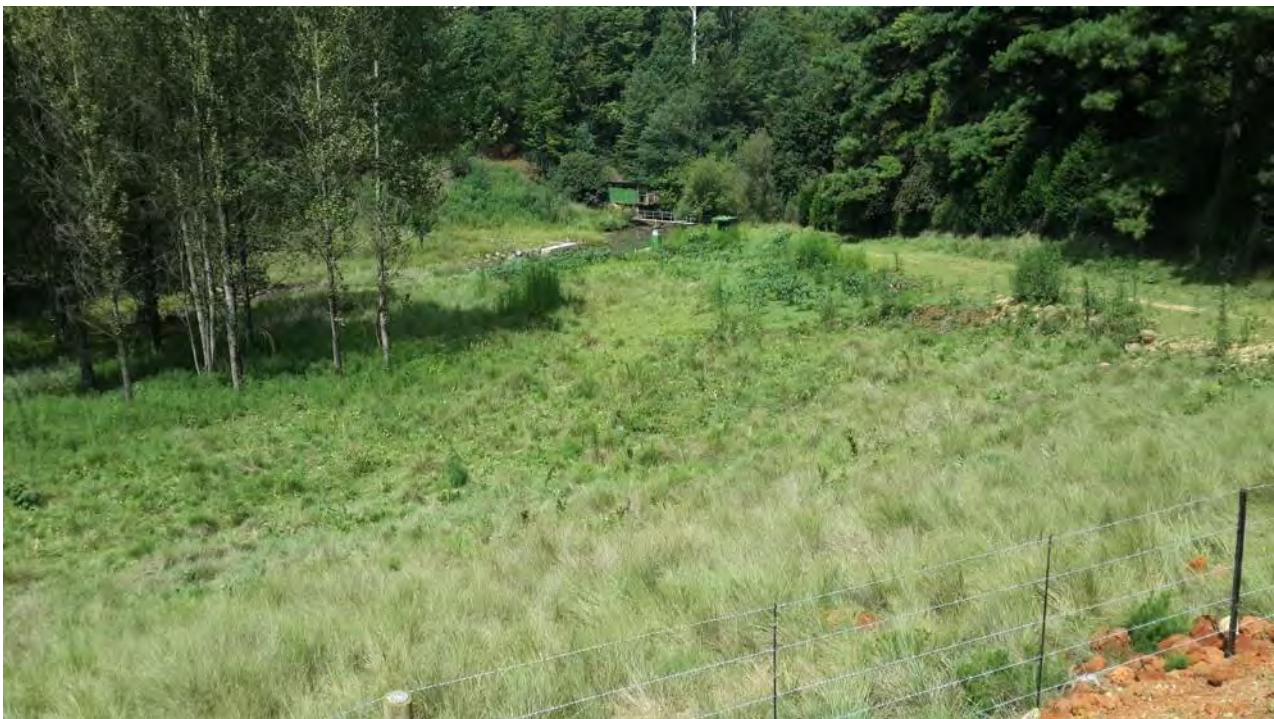
- Weeds were identified in certain of the rehabilitated areas (see examples shown in **Figure 13**). Although the root systems of these weeds are assisting in stabilising the soil, their growth needs to be controlled in a suitable manner.

**Figure 13:** Weeds at Mpofana weir

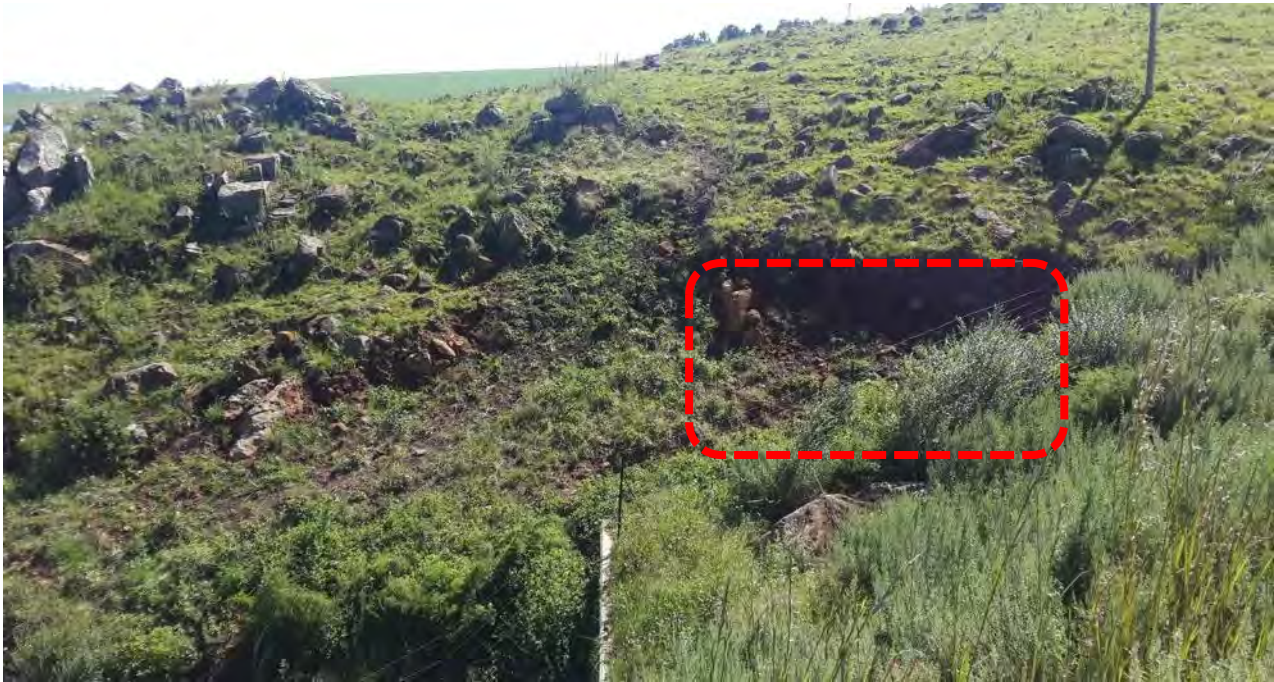
- The efforts of the Contractor in dealing with the bare areas recorded on the Snag List are acknowledged, as discussed in **Section 3.3**. These sites will be revisited for the remainder of the defects liability period to monitor the success of the rehabilitation measures.
- Bare areas identified during the ECO inspection are shown in **Figures 14 and 15**.

**Figure 14:** Bare area – Lower Loteni culverts downstream right bank

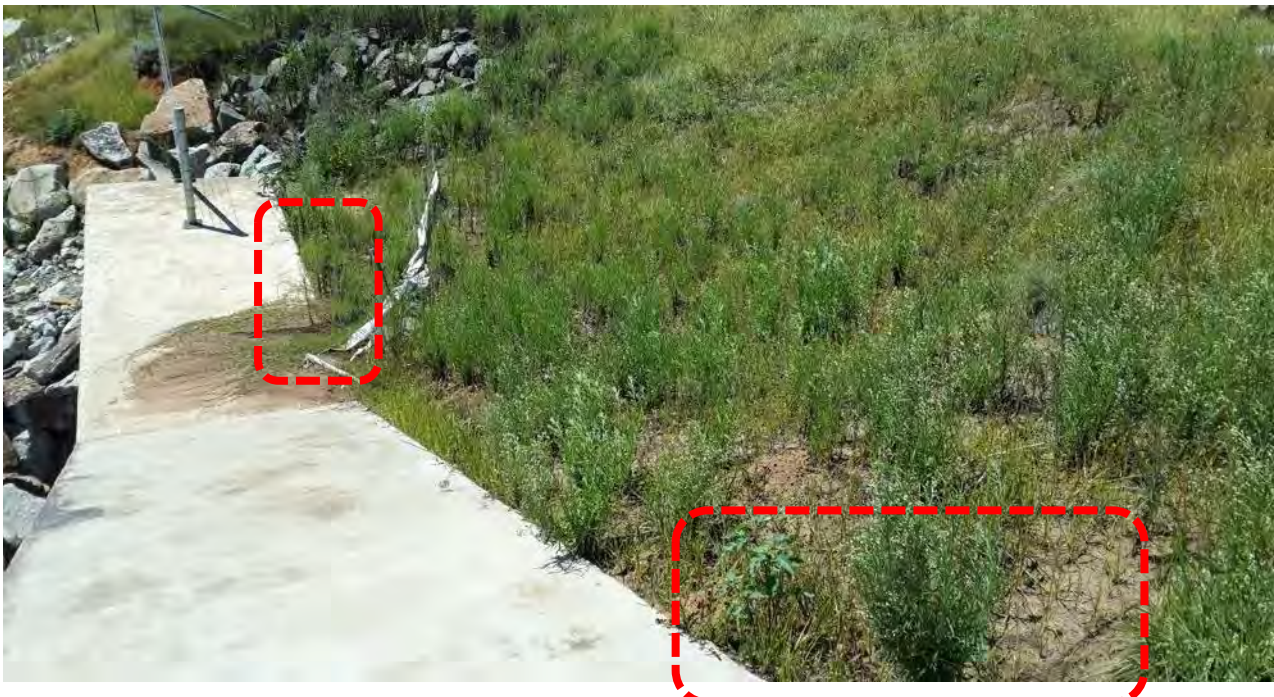
**Figure 15:** Bare area and cut – fish barrier right bank

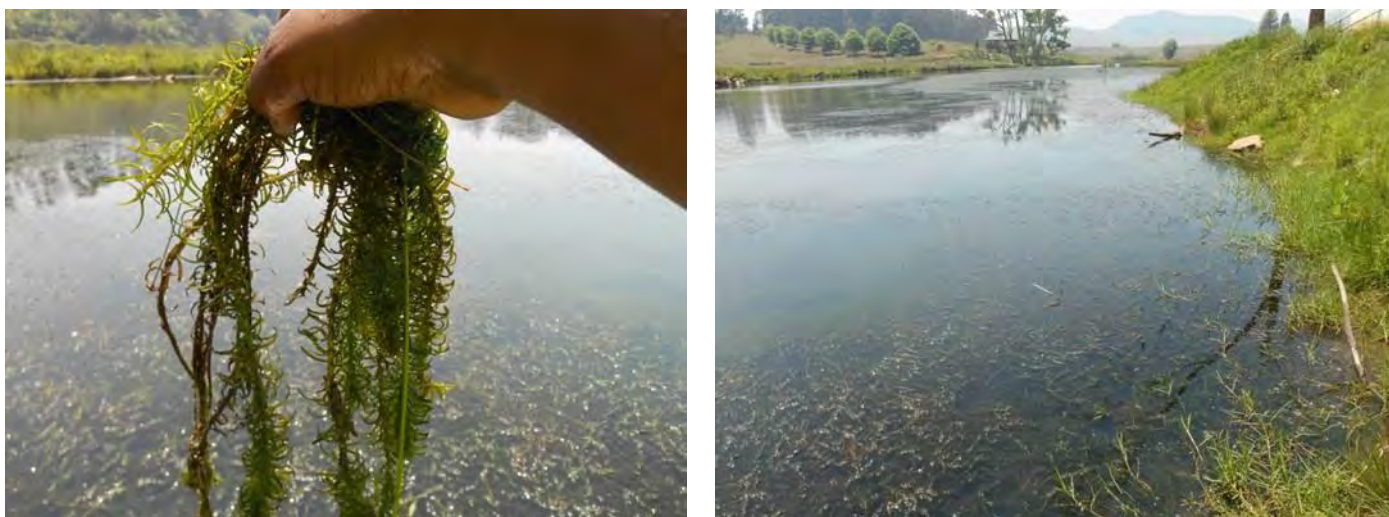
- The proliferation of an aquatic plant within Spring Grove Dam and the Fish Barrier impoundment has been recorded over a relative short period (refer to **Figure 16**). It is advised that DWS, Umgeni Water and the relevant mandated authorities further investigate this matter.

**Figure 16:** Aquatic plant proliferation
