MOOI MGENI TRANSFER SCHEME PHASE 2 (MMTS-2)

Construction of the Spring Grove Dam & Appurtenant Works

MONTHLY ECO REPORT : December 2012

Report Title: **Monthly Environmental Control Officer Report**

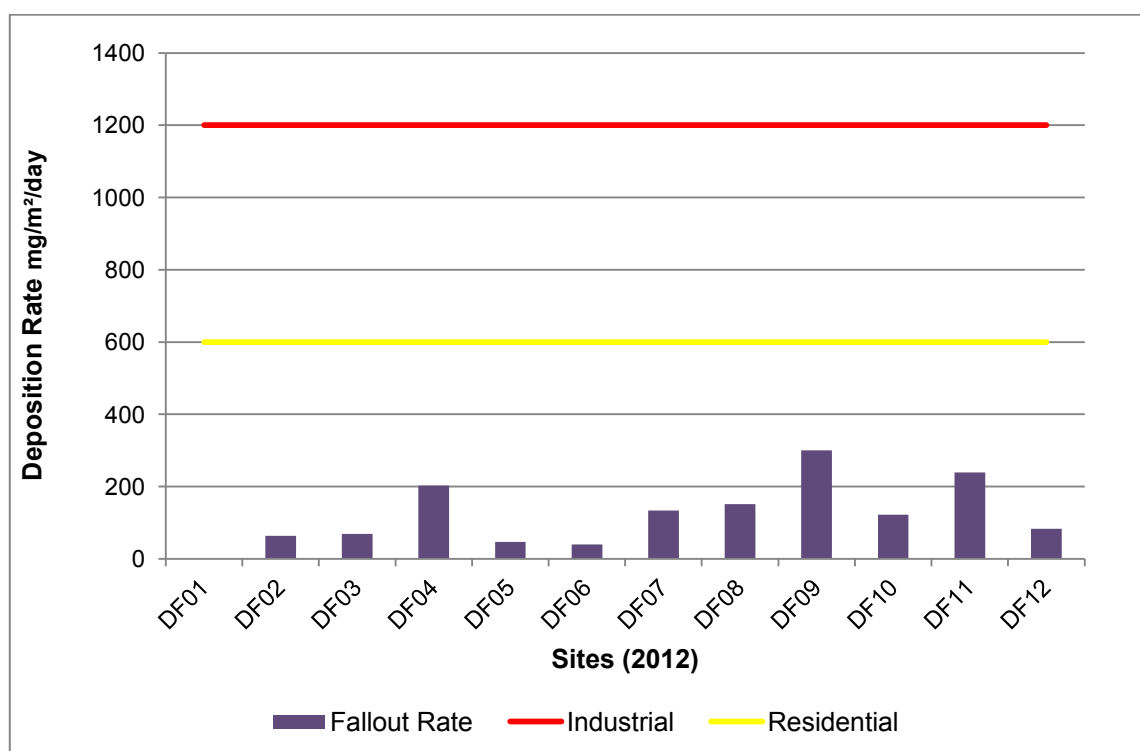
Figure 7: Dust fallout rates for October 2012 (Blue Sands, 2012a)

- Dust fallout rates continue to remain well-within the Residential Band.
- Decreased dust load is being measured as a result significantly wetter spring conditions, in spite of on-going hauling, stockpiling, mixing and on-site transport.

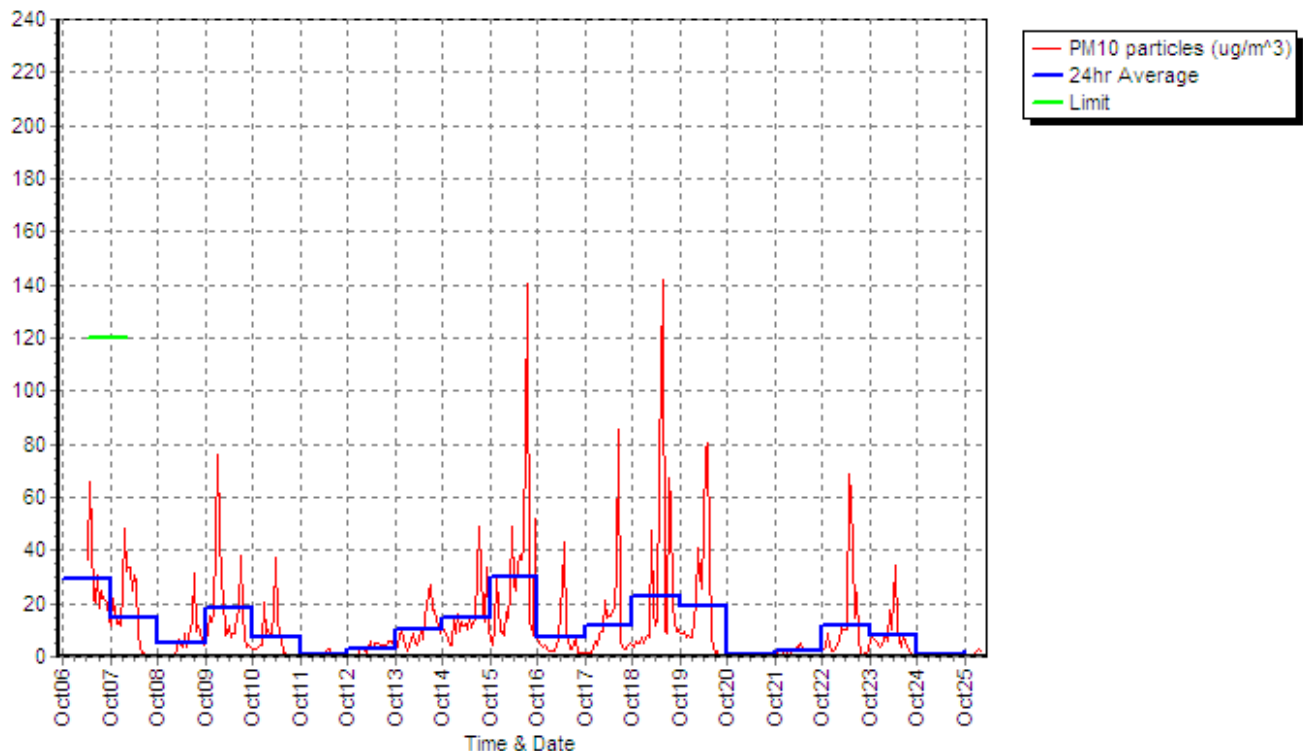
Figure 8: PM₁₀ concentrations for 06 – 25 October 2012 (Blue Sands, 2012a)

- During October 2012, the PM₁₀ concentrations were fully compliant with the 24-hour limit of 120 $\mu\text{g}/\text{m}^3$.
- The pollution rose (see **Figure 9**) shows that the major contribution to the dust levels recorded came from the northerly sector. There are two sources in this area; one being the aggregate stock pile and the other being the parking area for the office block.
- Reviewing historical trends, it is interesting to note that the most dust either originates from the aggregate stockpiles (under windy conditions) or the road (under calm conditions).

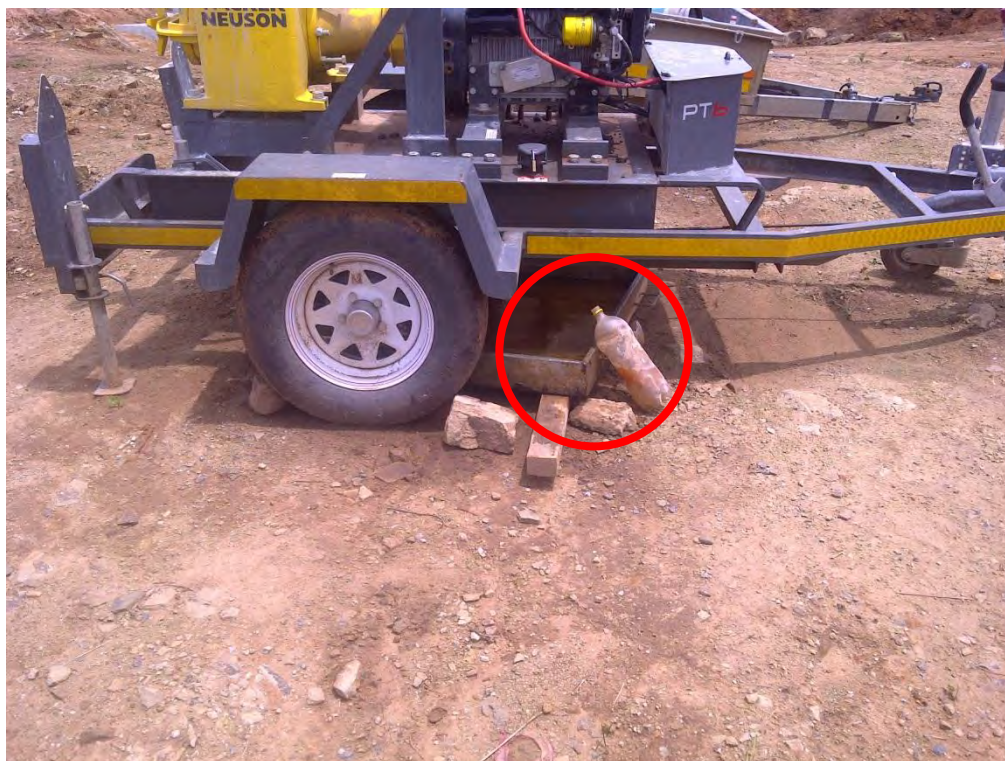
Monitoring Category	Condition / Mitigation Measure	Comments
		secondary containment of hazardous material in case of spillage. Overflowing drip tray at fish barrier (Figure 10).
	Screens, barriers and warning signs must be placed around excavations and wherever there is a hazard to workers, the public and animals	Barricading of excavations.
	During the construction phase the speed limit of 40km/h on public and other roads within the project area to be adhered to. This include roads and streets within Rosetta and Nottingham Road, sections of the R103, road D146, the access road to the Vaalekop South smallholdings and Riverholm, the Balgovan road for accessing the Mpofana outfall works (N3 Toll 25) and the access road to the quarry site on Springvale Farm 2170	Complaint received regarding speeding - verified.
	Security measures to be implemented to ensure the safety and security of the workers, material and surrounding communities	Ongoing. Toolbox talks undertaken. Controlled access to site: locked gate; security guard and access register. Complaint received regarding unlocked gate.

Figure 10: Overflowing drip tray and improper storage of container with hazardous material

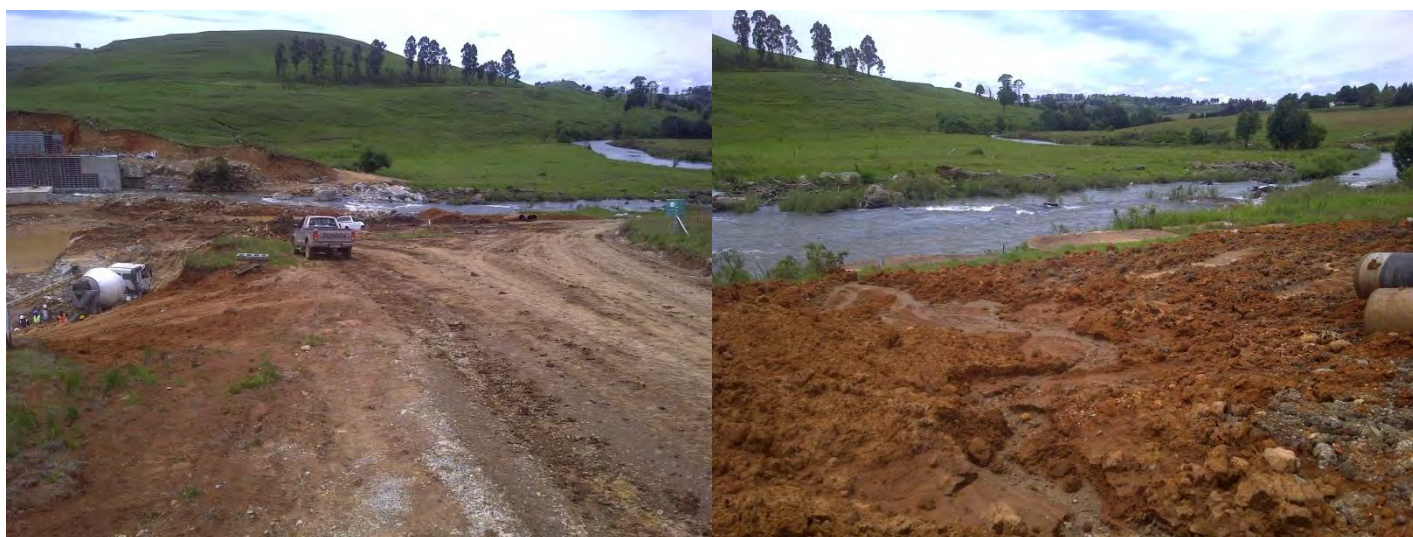
Monitoring Category	Condition / Mitigation Measure	Comments
	settlement ponds and managed before release. Silt, sand and silt-laden water shall not enter any surface watercourse.	instream works, cleared areas). Daily water quality monitoring results required to assess increase in TDS. Require storm water management at fish barrier site and on access road to this site.
	Such overland discharge may not cause erosion	Runoff generated from watering down of aggregate stockpiles is discharged over land, which is eventually collected in an attenuation pond. Potential for erosion to be monitored. Possible erosion on steep slopes to be monitored. Require storm water management at fish barrier site and on access road to this site.
	Erosion prevention measures such as the placing of gravel or rip rap; or in some cases plastic or mesh covering to be implemented	Erosion control measures: rip raps in place at Mooi River temporary crossing; settling pond at the end of the river diversion bank; cut off trenches implemented at Derek Green's farm; along the topsoil stockpiles located above Afrisam batch plant and below the two spoil sites. Require storm water management at fish barrier site and on access road to this site.

Figure 11: Lack of stormwater management at fish barrier site

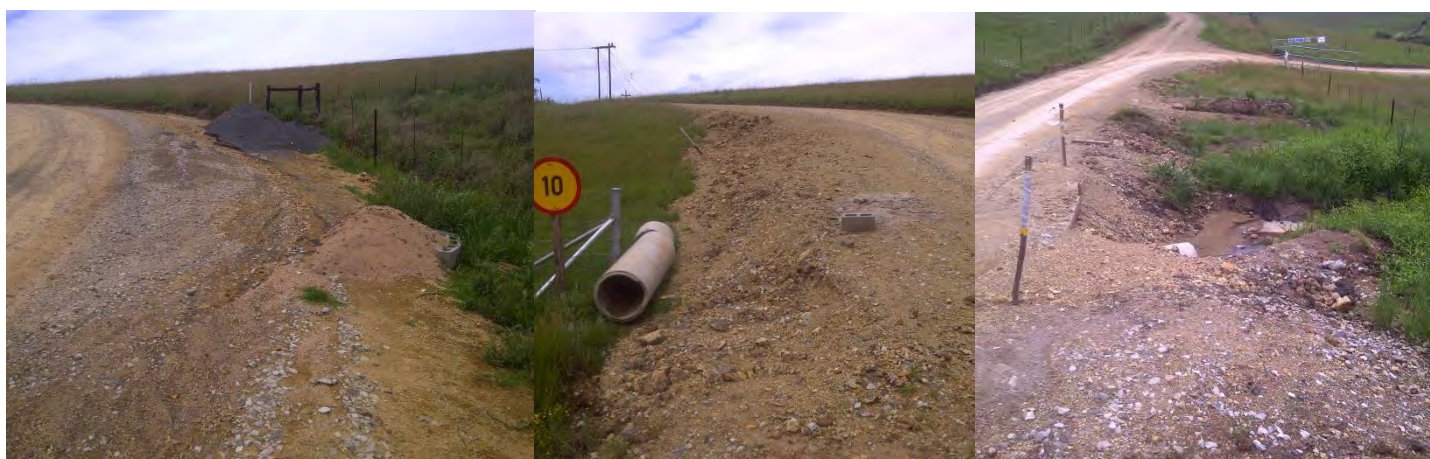
Figure 12: Lack of stormwater management on road approaching fish barrier site

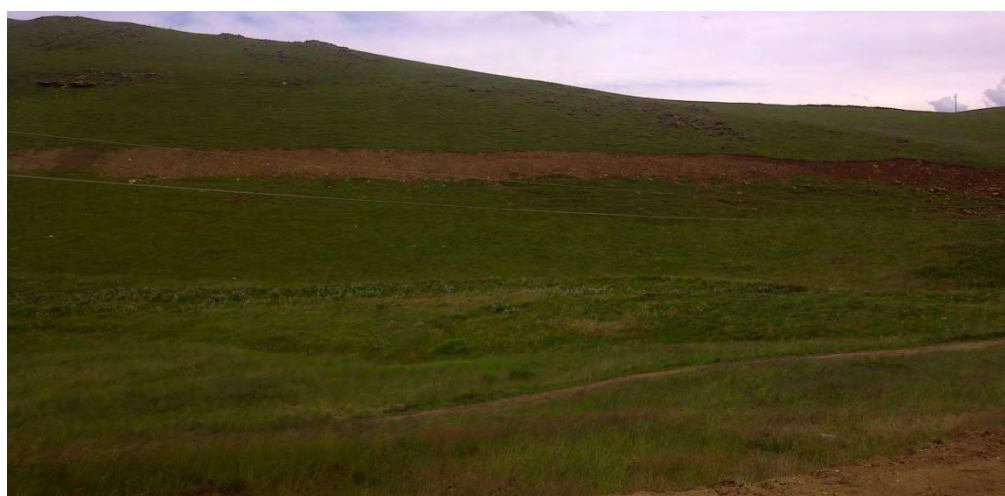
Figure 13: Risk of bramble spreading onto area affected by grading of road

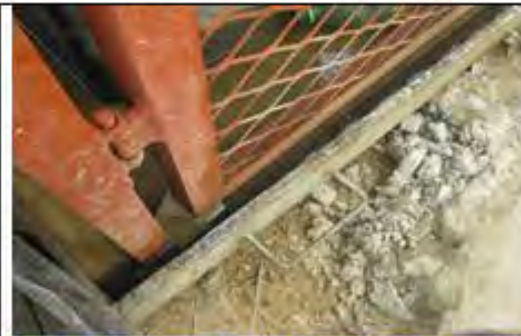
Fig. 17: On 05 December 2012 (date of last weekly inspection), the bunding under the hazardous materials storage cage on the left bank was inadequate in size and close to overflowing with contaminated water.

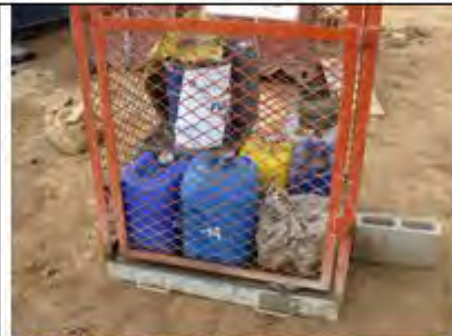
Fig. 18: During this inspection, cage has apparently been relocated to the right bank above the RCC and near the mechanic's container. Although the bunding had been emptied it still is an inadequately sized bund.

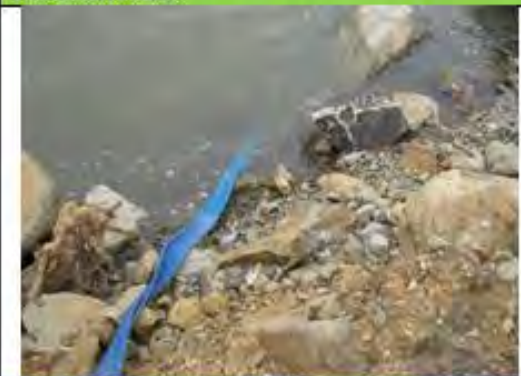
Fig. 19: On 05 December 2012 (date of last weekly inspection), dewatering sock present below the dam foundation at the spillway was not connected to any pump line, rather the dewatering hose pipe was placed directly into the river.

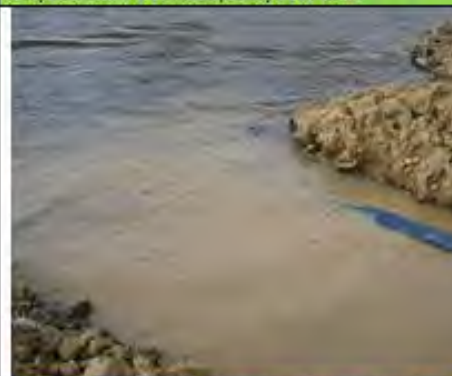
228	Safety	Absence of safety barricading on steep slope on right bank from the tongue to the RCC wall.	Open
229	Pollution Prevention	Defective watering sock at the spillway causing sediment to be released without containment.	Open

Fig. 20: During this inspection, dewatering sock present below the dam foundation at the spillway was not connected to any pump line, rather the dewatering hose pipe was placed directly into the river and siltation was evident.

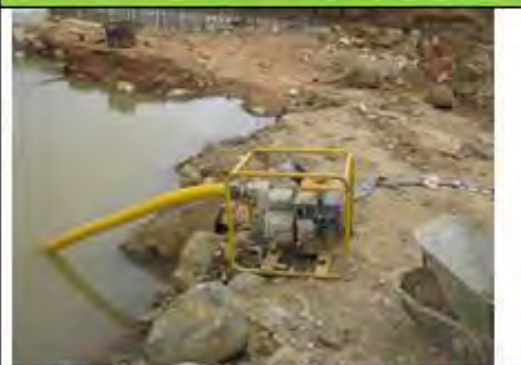
Fig. 21: On 05 December 2012 (date of last weekly inspection), drip trays were missing from under diesel powered equipment in the container at the workshop, RCC trial area and Spring Grove gauging weir (above).

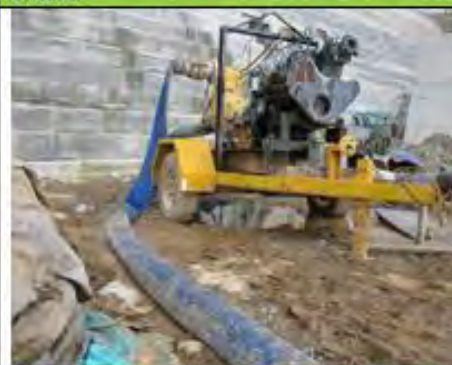
Fig. 22: During this inspection, drip trays were absent from under diesel powered equipment at the river diversion (fish barrier), right bank, and the spillway below dam foundation (above).
