# MOOI MGENI TRANSFER SCHEME PHASE 2 (MMTS-2) Construction of the Spring Grove Dam & Appurtenant Works

## MONTHLY ECO REPORT : August 2012

*Report Title:* **Monthly Environmental Control Officer Report**

*Date of issue:* **21 August 2012**

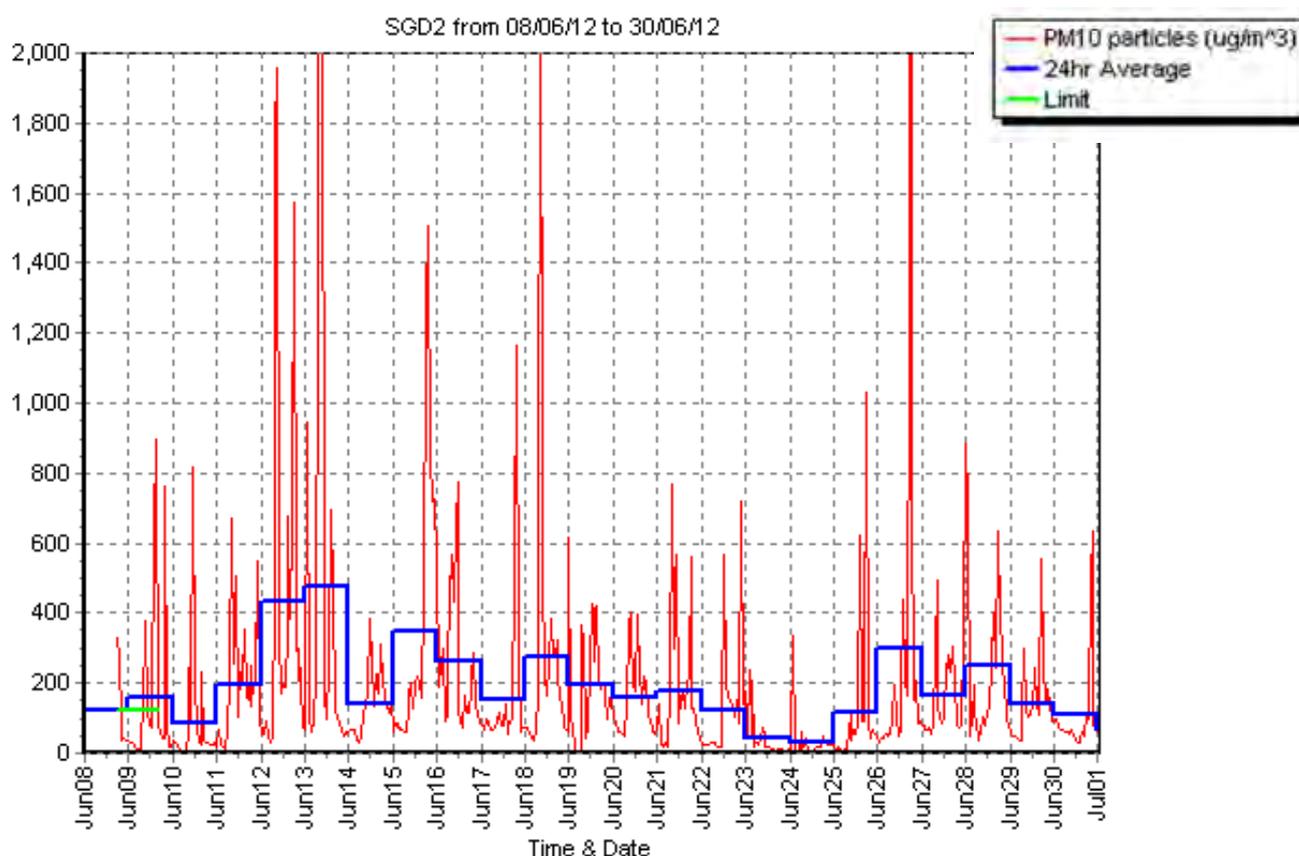
**Figure 13:** PM<sub>10</sub> concentrations from 08 – 30 June 2012 (Blue Sands, 2012a)

- During June 2012, the PM<sub>10</sub> exceeded the 24-hour limit of 120 µg/m<sup>3</sup> for 17 days in total. The top ranked exceedences are examined in **table 1**.

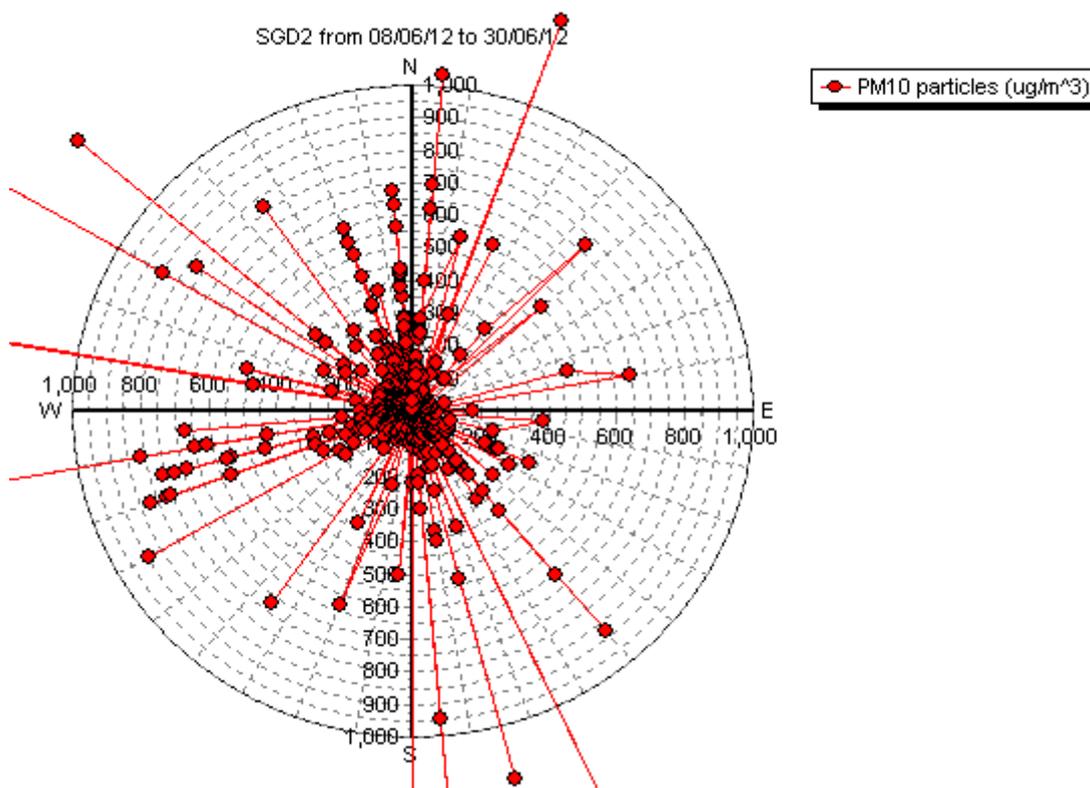
- The pollution rose (see **Figure 14**) shows that the major contribution to the dust levels recorded came from the D146 and from an area north of the office block. There are two sources in the area north of the office block one being the aggregate stock pile and the other being the parking area for the office block. Another source also from south-west, which relates to hauling and activities at the dam wall.

**Figure 14: 1-hour PM<sub>10</sub> pollution rose from 08 – 30 June 2012 at site SG01 (Blue Sands, 2012a)**

- Blue Sands (2012a) recommended that the Contractor will need to increase the frequency of the water cart irrigation if possible, or utilize additional carts to keep unpaved roads wet

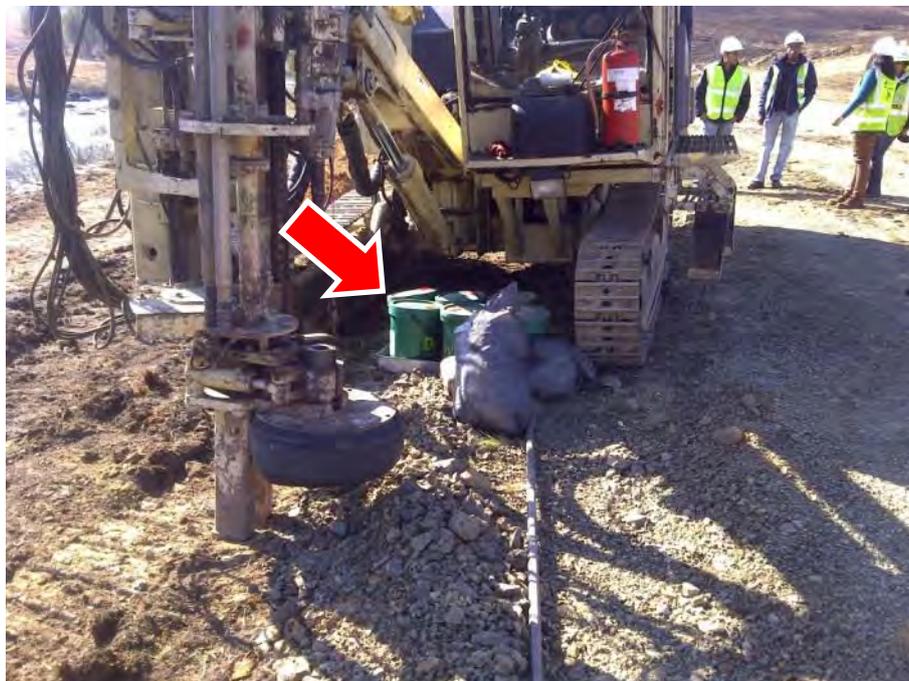
Bund volumes of drum storing chemicals to have sufficient capacity for spill containment	Secondary containment required for all chemicals on site ( <b>Figure 15</b> ).
	A record of all types and quantities of hazardous materials on site to be kept	Hazardous material register available, which records fuel at bulk storage area. Need to include hazardous material in containers.

**Figure 15:** Inadequate secondary containment of hazardous material

Drip trays to be provided for all equipment that poses a risk of contamination. This was a common problem identified during the weekly inspections. Hazardous material needs to be stored in accordance with the regulatory requirements and the MSDSs.

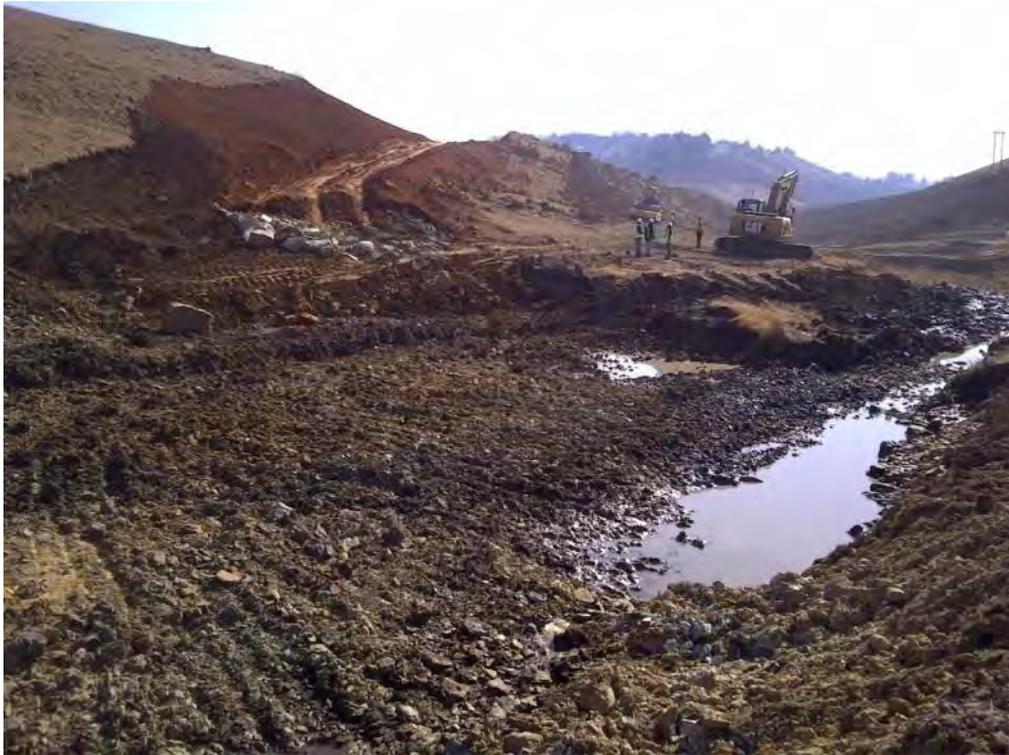
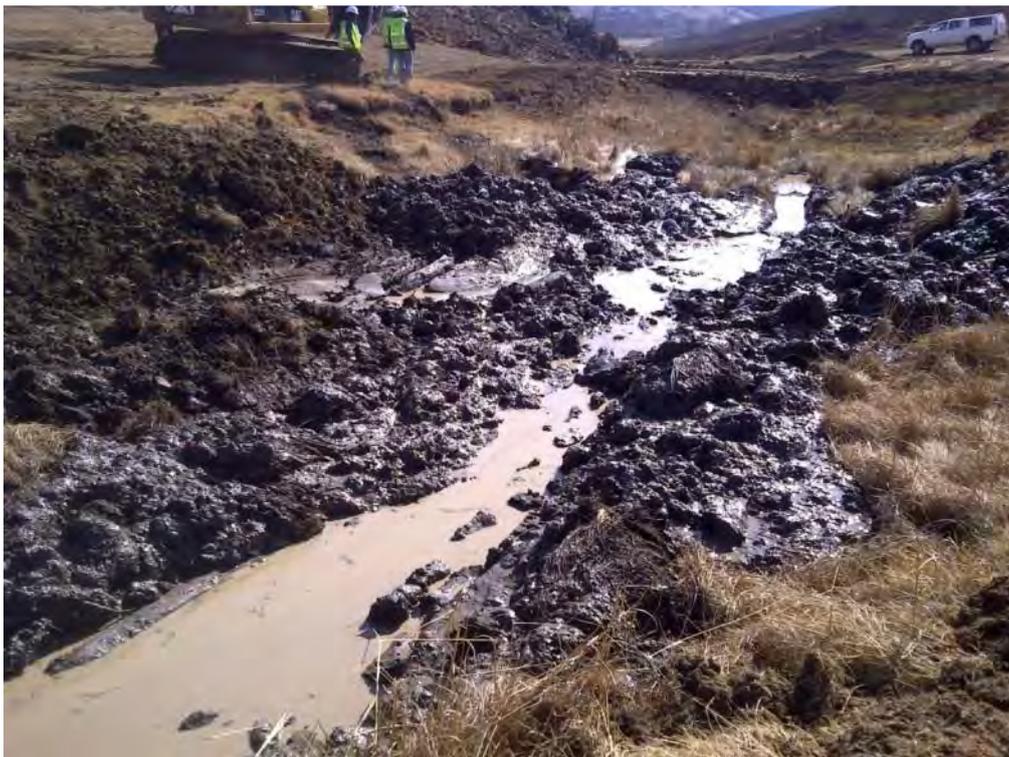
Silt laden water shall not be directly discharged over land or directly into watercourses and shall be contained in settlement ponds and managed before release	No provision for management of siltation at instream works. ( <b>Figure 16</b> ).
Waste	Site to be kept clean and free of litter	<ul style="list-style-type: none"> <li>Complaint received regarding litter.</li> <li>Diesel rags inappropriately disposed of on site (<b>Figure 18</b>).</li> <li>Spillage from hazardous waste in bags at workshop left on ground (<b>Figure 19</b>).</li> </ul>
Search, Rescue and Relocation	Conduct a detailed search of the inundation area (including Inchbrakie Fall) during spring and summer, taking due cognizance of specialist studies already undertaken as part of the EIA process	Site surveys will be done during the flowering season. However, the current tree felling activities will jeopardise the ability to establish a baseline in terms of species occurrence and population sizes.

**Figure 16:** No provision for management of siltation at instream works – Route 11

A more pro-active approach is required to environmental management on the site. This is particularly relevant to sediment management at river crossings, where the sediment caused by construction activities should not be left to be assimilated by the watercourse without appropriate mitigation by the Contractor.

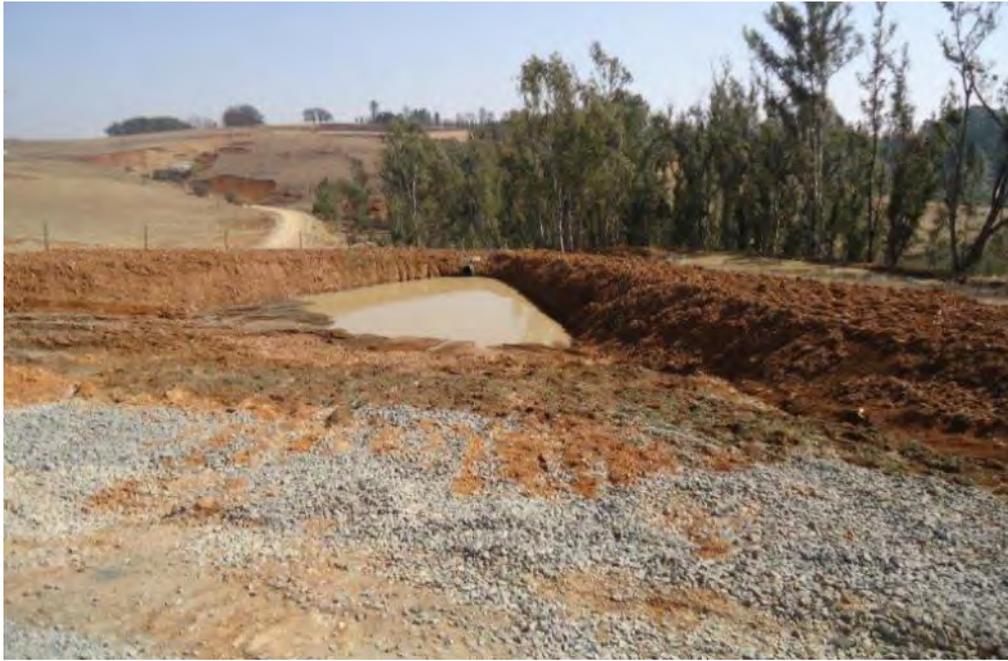
Monitoring Category	Condition / Mitigation Measure	Comments
	Flammable liquids to be issued only on a need-to-use basis and strict control to be implemented to ensure that the quantity drawn is what is needed for a specific job	On-going. Need to be checked by stores manager for sub-contractors. Contractor to advise on requisite improvements.
	Flammable liquid stores to be well ventilated and free of explosive vapours	Ventilation to be provided in containers where hazardous material is stored.
	Flammable liquid stores to be well ventilated and free of explosive vapours	
Fire Risk	Necessary precautions to be taken to minimize fire risk on site	Complaint received regarding illegal fire at camp site for fish barrier.
Water Quality	Cement-laden water can only be discharged at the batch planting facility to settlement and treatment ponds	Silted-up ponds at the bottom end of the batch plant to be deepened ( <b>Figure 17</b> ).

**Figure 17:** Silted-up ponds at the batch plant to be deepened

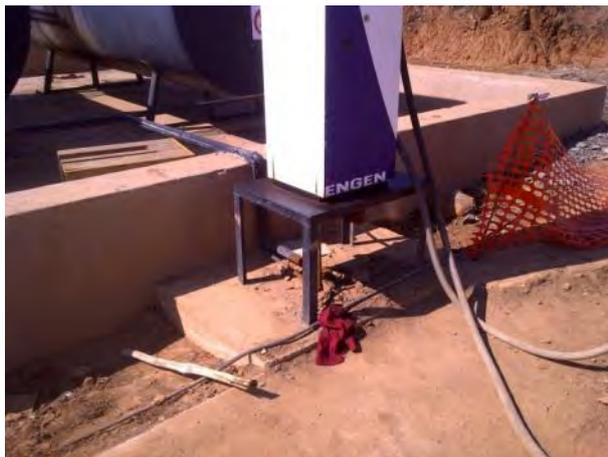
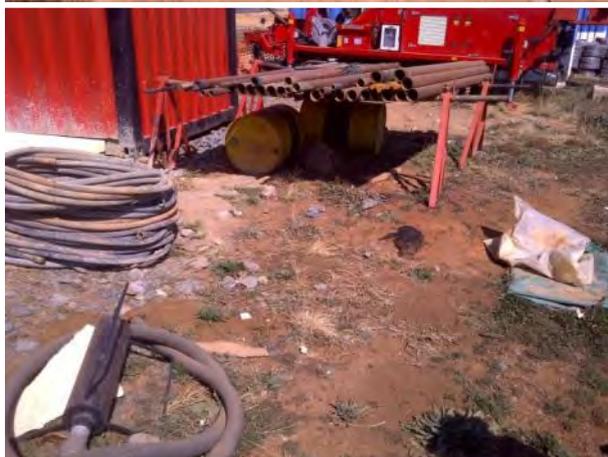
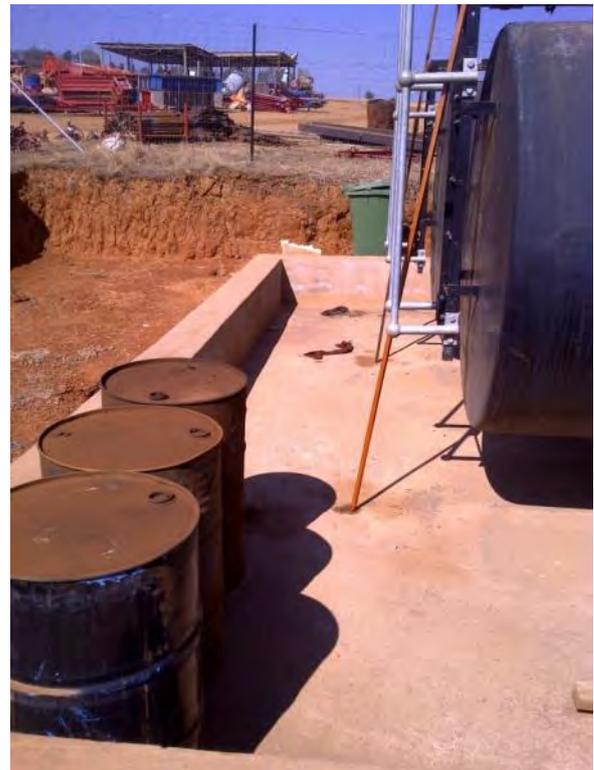
**Figure 18:** Diesel rags inappropriately disposed of

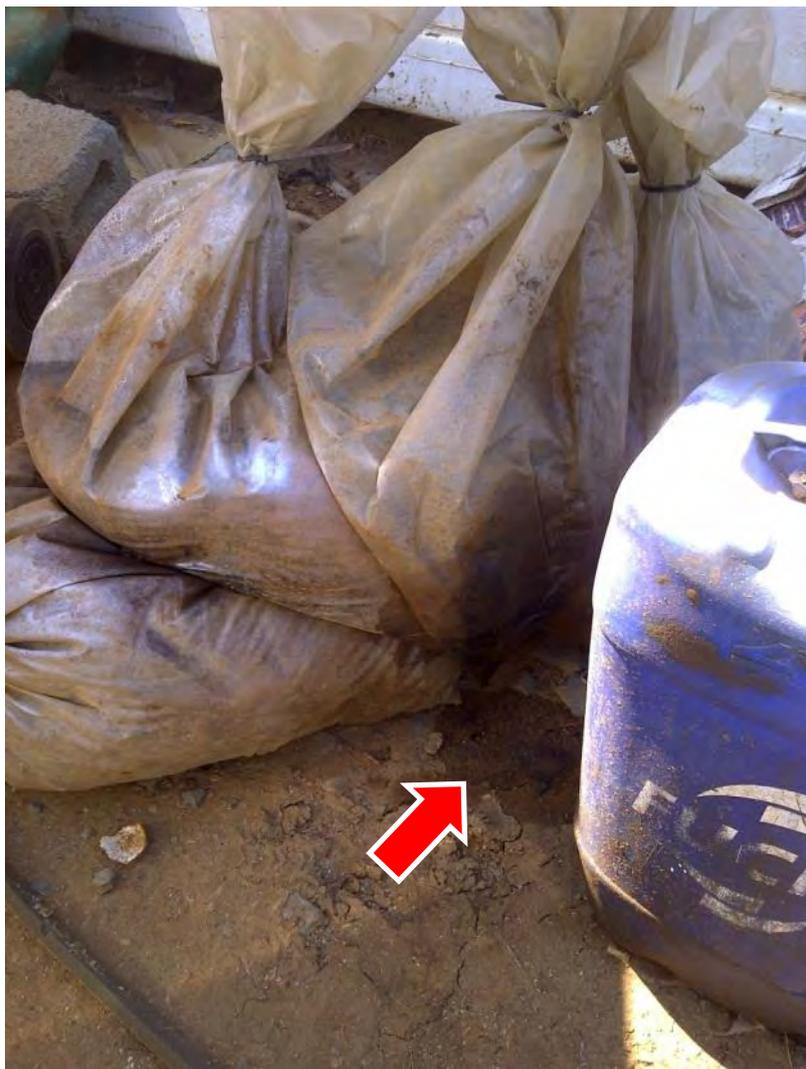
**Figure 19:** Spillage from bagged hazardous waste

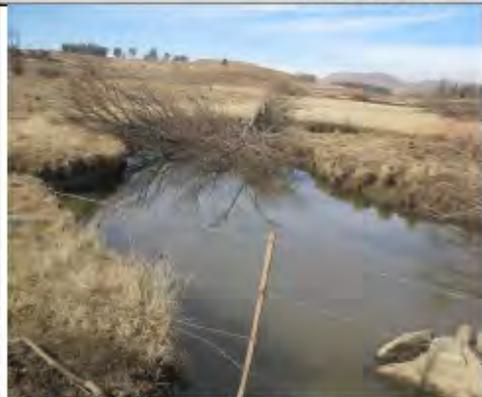
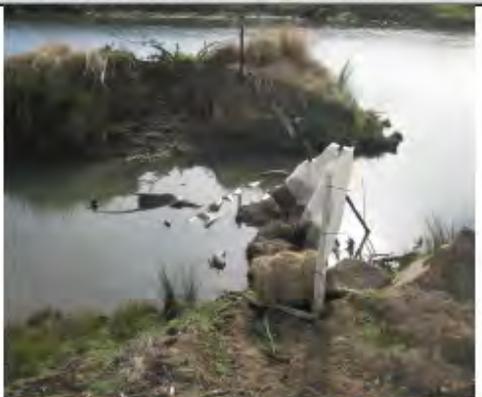
<p>Fig 3: Felled trees in waterway at stream crossing on way to Route 13</p>	<p>Fig. 4: Silt barrier at stream crossing #3 in need of adjustment</p>

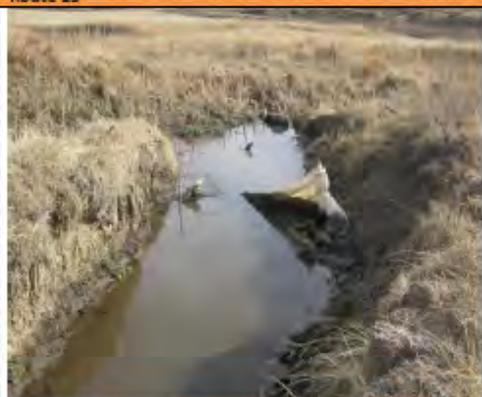
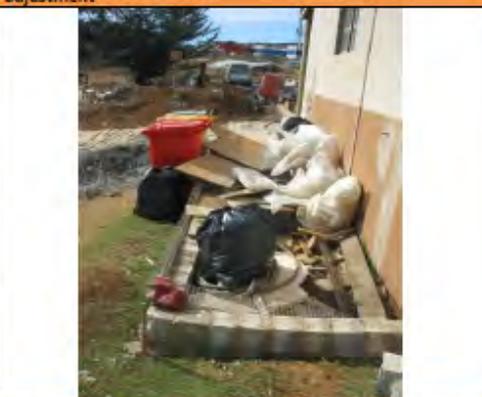
<p>Fig 5: Silt barrier at stream crossing #2 in need of adjustment</p>	<p>Fig. 6. Housing keeping required at the lab area (general waste to be removed)</p>
