MOOI MGENI TRANSFER SCHEME PHASE 2 (MMTS-2)

Construction of the Spring Grove Dam & Appurtenant Works

MONTHLY ECO REPORT : May 2012

Report Title: **Monthly Environmental Control Officer Report**

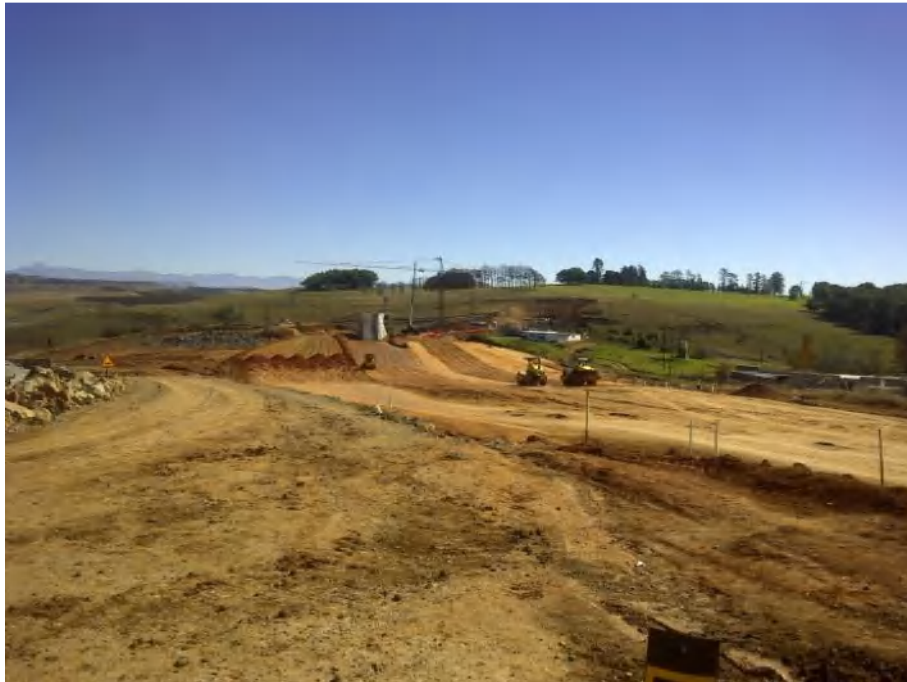
- Backfilling of the earth embankment (see **Figure 2**);
- Pipe installation at the earth embankment is ongoing;
- Excavation and hauling of the clay soil adjacent to Millican's house is ongoing;

Figure 2: Backfilling of earth embankment

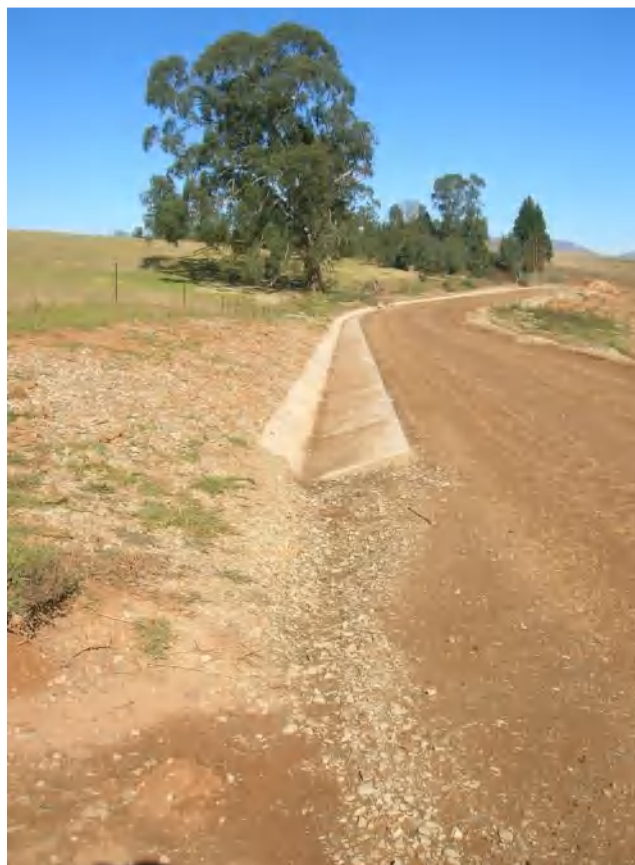
- Construction of a second coffer dam downstream from the dam wall;
- Use of a borrow pit for the dam's earth embankment on Garlic property is ongoing;
- Construction of a concrete drainage channel adjacent to the permanent access road into the dam basin (see **Figure 3**);

Figure 3: Concrete drainage channel

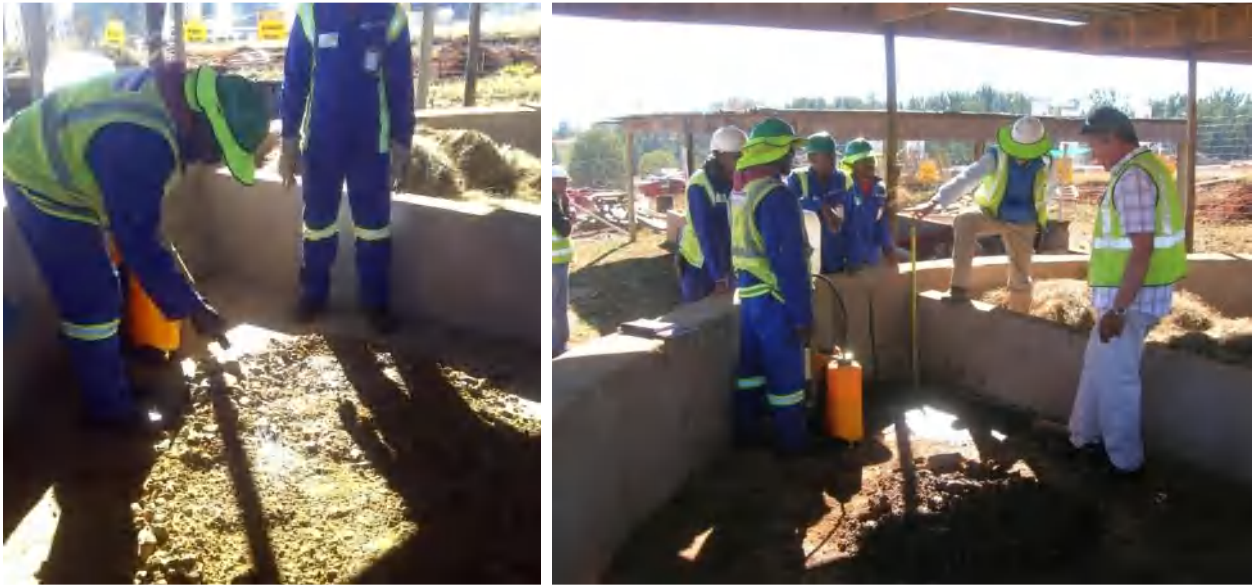
- Test trial of the substance "Oilcap" a hydrocarbon encapsulator for the *in situ* treatment of soil contaminated with petroleum based products (see **Figure 4**);

Figure 4: Test trial of substance “Oilcap” (hydrocarbon encapsulator)

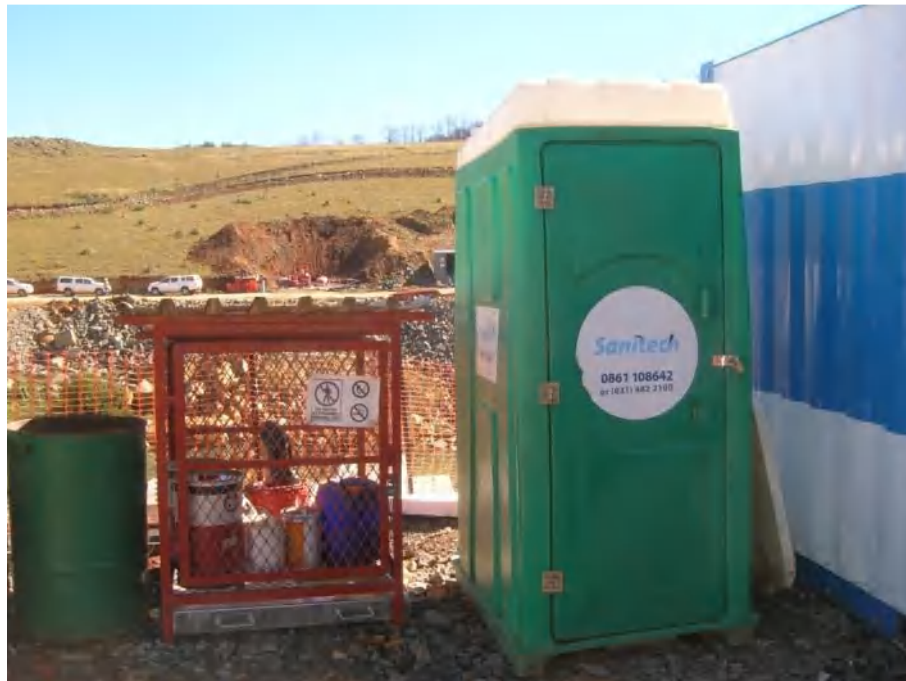
- On-going activities –
 - Regular dust suppression;
 - Safe storage and use of hazardous substances (see **Figure 7**);
 - Use of mobile toilets (see **Figure 7**);

Figure 7: Use of mobile toilets & storage of hazardous substances

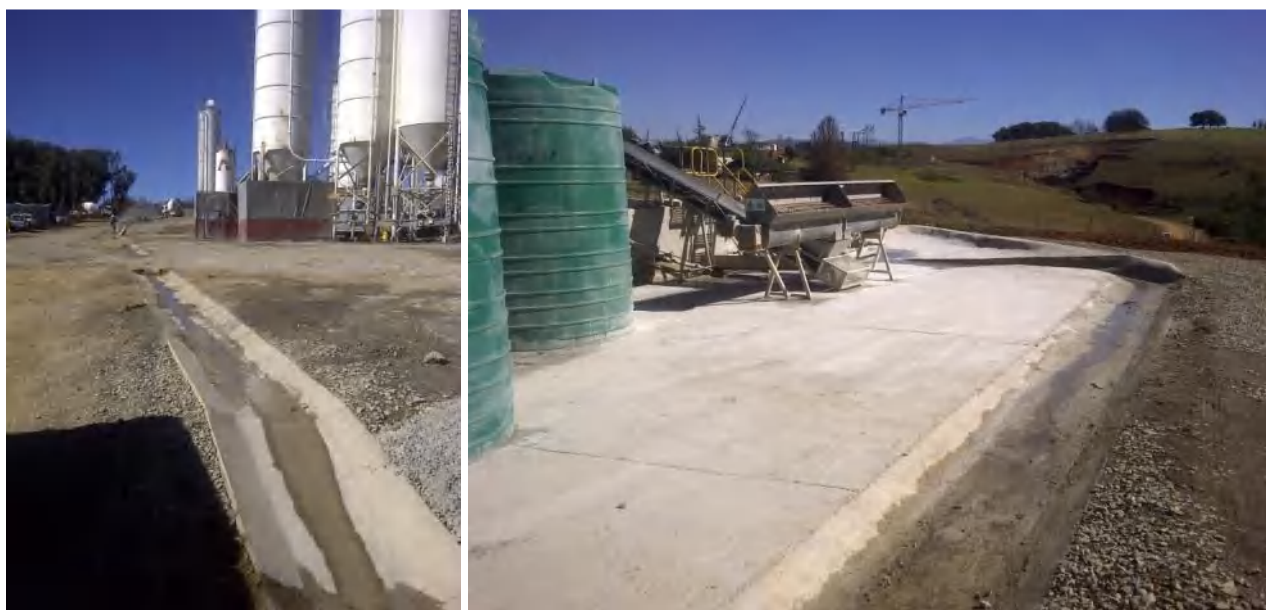
- Safe capturing of a snake for release (see **Figure 10**);
 - Dewatering through silt socks (see **Figure 11**);
 - Rectification of wastewater management issues at batch plant (see **Figure 12**);

Figure 12: Improved wastewater management

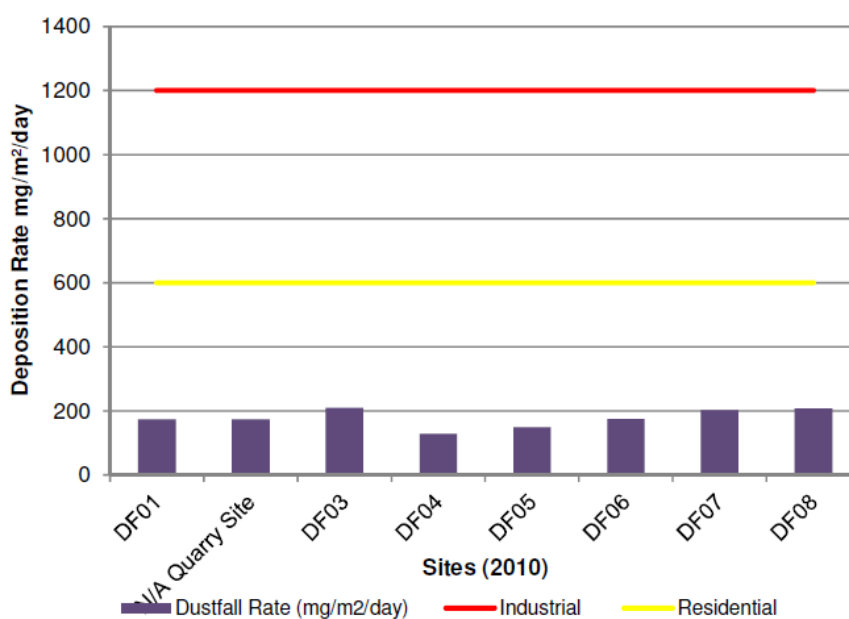
- The samples were collected on 30 March 2012, with a sampling period of 31 days.
- The average dust deposition rates for 2010 Baseline Air Quality Survey follows.

Figure 13: Average dust deposition rates for 2010 Baseline Air Quality Survey

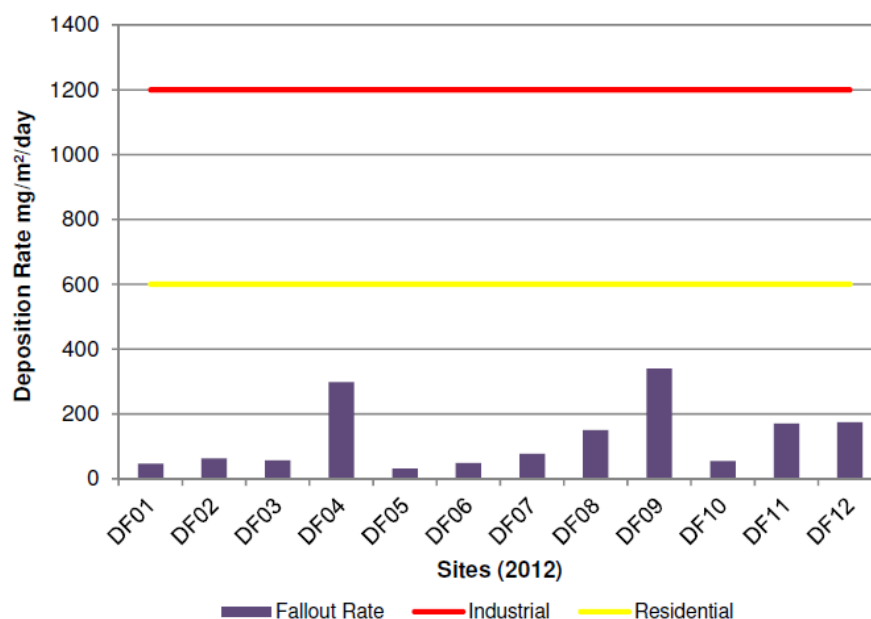
- Dust fallout rates remained well within the residential band (see **Figure 14**).

Figure 14: Dust fallout rates for Mar 2012 compared with SANS limit values (Blue Sands, 2012a)

- Marked increases from baseline dust fallout rates were recorded at sites DF04 (Construction Site, North Fence) and DF09 (between Offices and D146). However, the rates were still below the SANS limit values for the residential band.

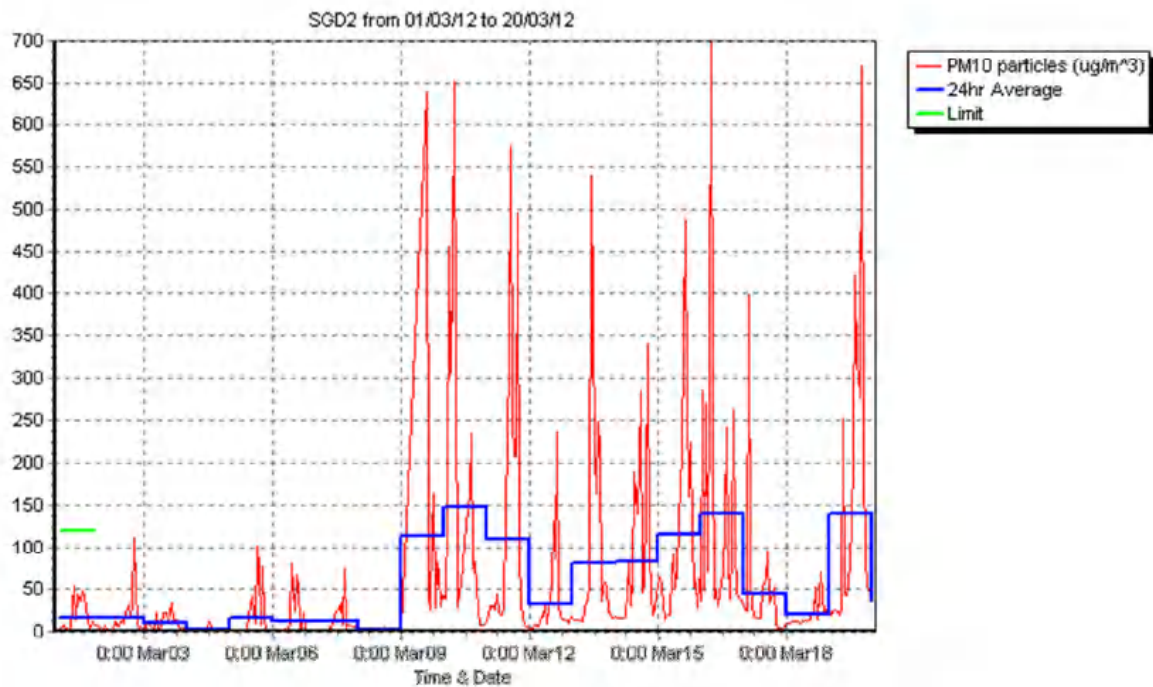
- The sample period was from 01 – 20 March 2012.
- The PM₁₀ concentrations are all below the 24-hour limit of 120 µg/m³, with the exception of three exceedences recorded for 10, 16 and 19 March 2012 (24-hour averages) (see **Figure 15**). A possible reason for the exceedance was provided by Blue Sands as follows: “As these days were close to or during weekends, it may be that the watering schedule was not as rigorous as during the mid-week...”. It is noted that no dust-related complaints were received on these days.

- The pollution rose shows that the major contribution to the dust levels recorded came from the D146 and from an area north of the office block. There are two sources in the area north of the office block one being the aggregate stock pile and the other being the parking area for the office block. During the monthly ECO monitoring event it was observed that the area around the office block was being watered down (see **Figure 16**).

Figure 15: PM₁₀ concentrations from 01 – 20 March 2012 (Blue Sands, 2012b)

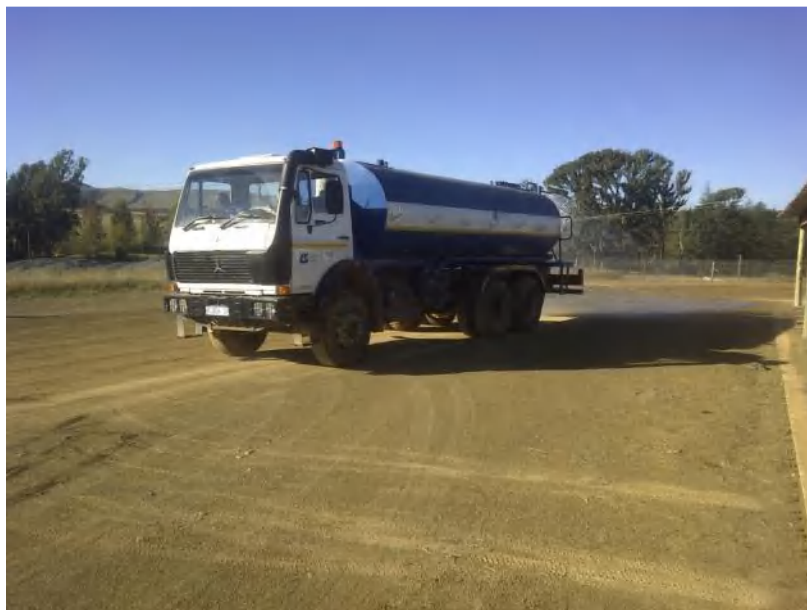
Figure 16: Watering down of area around office block

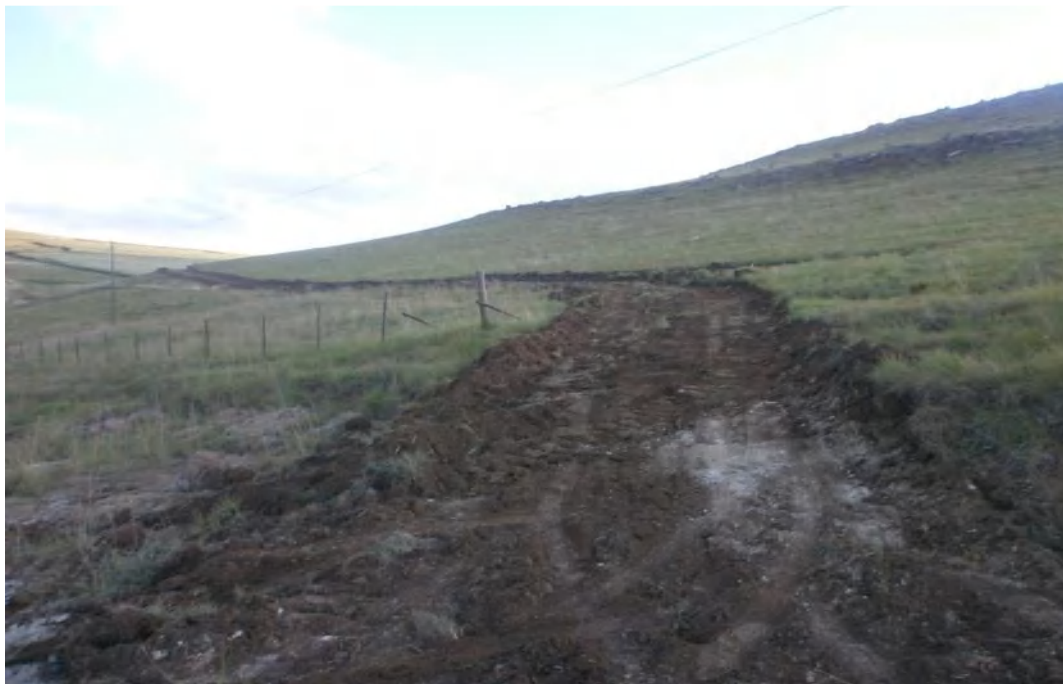
Figure 17: Road graded by fencing contractor through natural veld

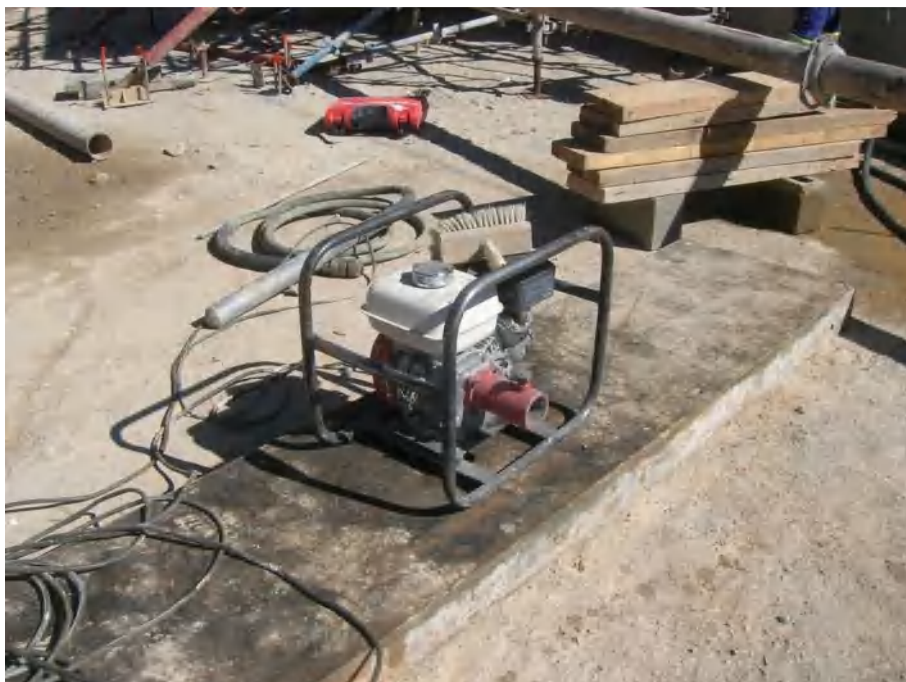
Figure 19: Drip tray required

Provisions of the Hazardous Substances Act (Act 15 of 1973) to be adhered to	
Waste disposal certificates to be maintained on site by the EO	
Products to be kept in the original containers unless they are not re-sealable; with all products and containers being labelled and original labels and MSDSs retained	
All hazardous materials to be stored in clearly identified containers or vessels	<ul style="list-style-type: none"> • Inadequate storage of hazardous material - containers to be labelled and secondary containment required (Figure 19). • Copies of MSDSs to be kept at storage areas and in file.
Containers to be labelled so that the hazard nature of the material is clear	
Flammable liquid containers to be clearly labelled and to be provided with earthed drip trays

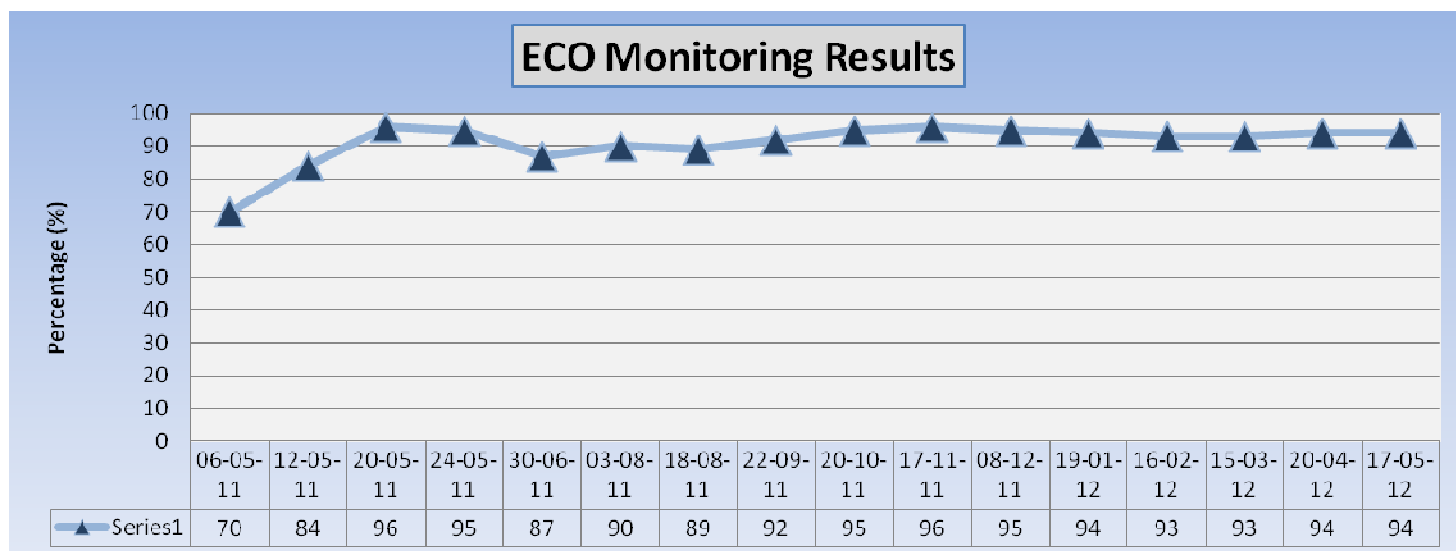
A graph indicating the sequential ECO Monitoring Results from May 2011 until present follows.

Figure 20: Graph - summary of results of Monthly ECO Monitoring Checklists
