MOOI-MGENI TRANSFER SCHEME PHASE 2 (MMTS-2)

Construction of the Spring Grove Dam Wall

FINAL ENVIRONMENTAL AUDIT REPORT 01

Held on 29 September 2011 on Site

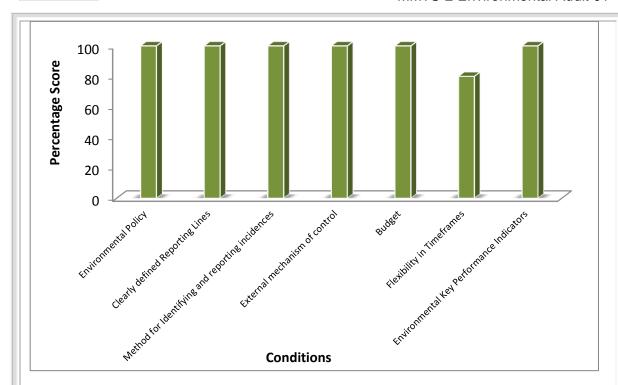
Based on the information obtained during the Programme audit, the overall compliance score was calculated at 97%. Figure 2 provides a graphical representation of the compliance scores for each aspect. These scores were calculated using a scoring system which is provided in Appendix 4.

Figure 3: Compliance Scores of MMTS-2 Programme Audit from 29 September 2011.

The project's environmental programme received 100% for all aspects except flexibility in timeframes. The timeframes are relatively tight. However, there are allowances made for environmental issues hence the compliance score was 4 out of 5 (80%). The presence of numerous external mechanisms of control, comprehensive environmental policy, environmental budget for monitoring and rehabilitation, defined reporting lines and key performance indicators based on environmental factors suggest that the MMTS-2 project is based on sound environmental management principles and best practices.

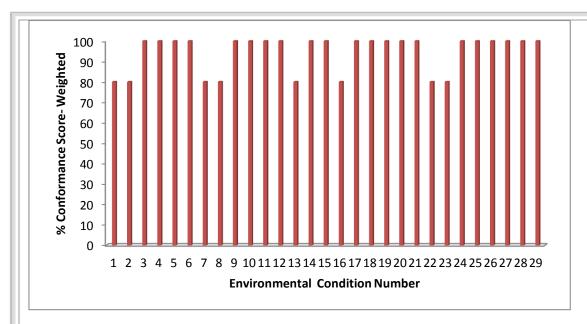
The Environmental Compliance Audit provided information of the overall compliance of the MMTS-2 project to the RoD and the EMP. The project is performing well in the majority of categories (Figure 4). An index of information contained in different locations needs to be added to the Environmental Manager's filing system. However no other problems were noted that cannot be easily remedied. In general, the Environmental Monitor and Environmental Manager have an up to date filing system containing all the information required from the RoD. In addition, the reporting lines regarding environmental concerns and incidents appear to be clear. The Non-Conformance register provides an adequate form of reporting environmental incidences together with the necessary time frames. In addition, toolbox talk registers and information suggests that there is quick action taken to remedy any environmental incidences. The site verification interview showed that MMTS-2 workers are knowledgeable about issues such as littering, protocol in cleaning spillages and safety.

Figure 4: Weighted Conformance Percentages for the Environmental Conditions Audited

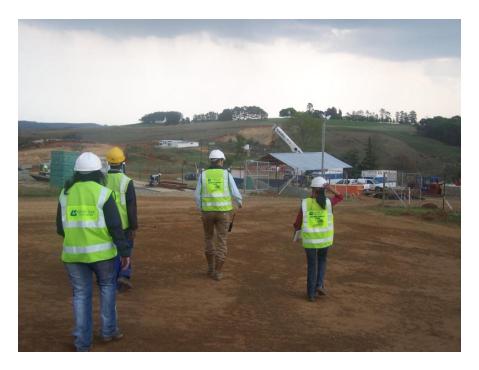
Figure 5: Site Verification

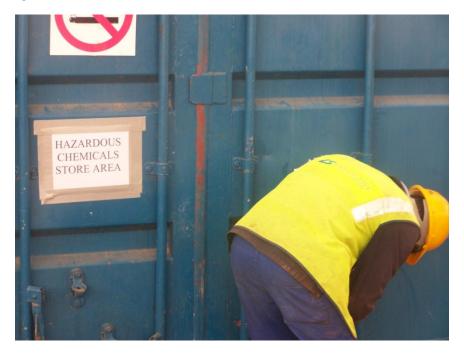
Figure 6: Site Verification of Hazardous Store
