MOOI MGENI TRANSFER SCHEME PHASE 2 (MMTS-2) Construction of the Spring Grove Dam Wall

MONTHLY ECO REPORT : September – October 2011

Report Title: **Monthly Environmental Control Officer Report**

Compliance Report No: **07**

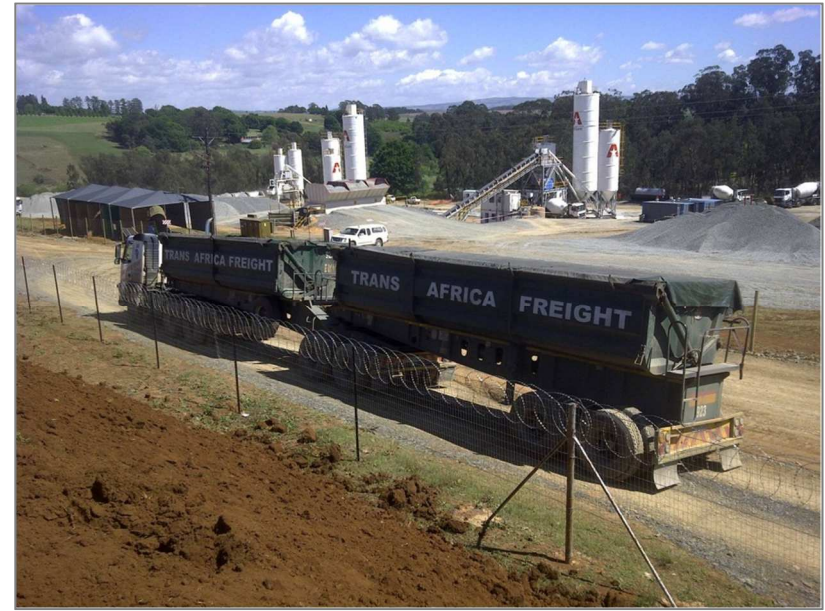
Figure 4: Concrete trial mix area

| Issue Ref. | Category | Summary of poor practice / area of concern | Status | |
|---|---|--|--|---|
| 049 | Pollution | 1. Storage of hazardous substances at the trial mixing area. | 1. During the last monitoring event no hazardous materials were observed at the trial mixing area. EM issued an NCR for inadequate storage of hazardous materials on site. | ✓ |

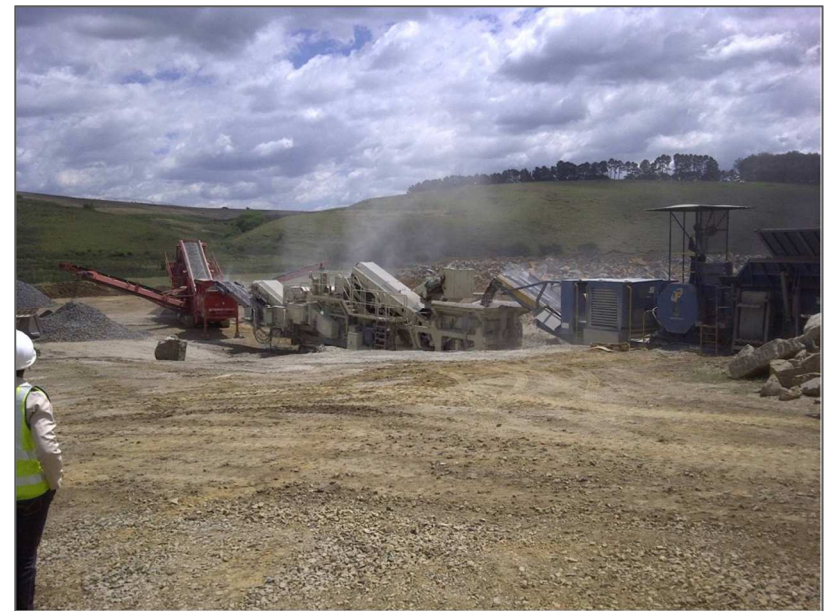
Figure 5: Operations at crusher area

| Issue Ref. | Category | Summary of poor practice / area of concern | Status | |
|---|---|--|--|---|
| | | 4. Spillage observed under the stationary crusher at the crusher area. | 4. Spillage removed on 27 September 2011. | ✓ |

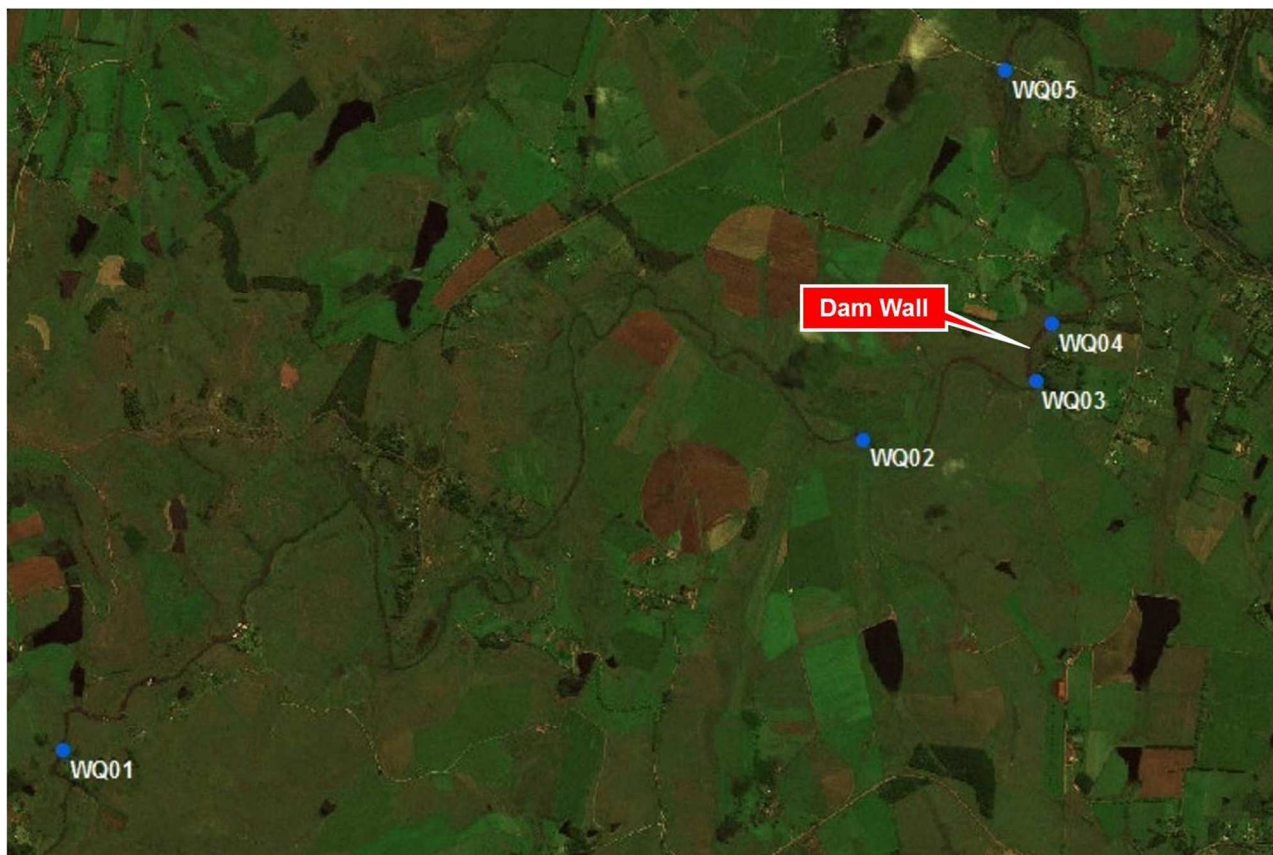
Figure 12: Water Quality Monitoring Points

Explanations are required for the exceedance of threshold levels for 22 August 2011 for the following variables at WQ03 and WQ04 (see map contained in **Figure 11**):

- Iron;
- Lead; and
- Zinc.

The potential contaminant sources, pollution pathways and impacts need to be investigated.

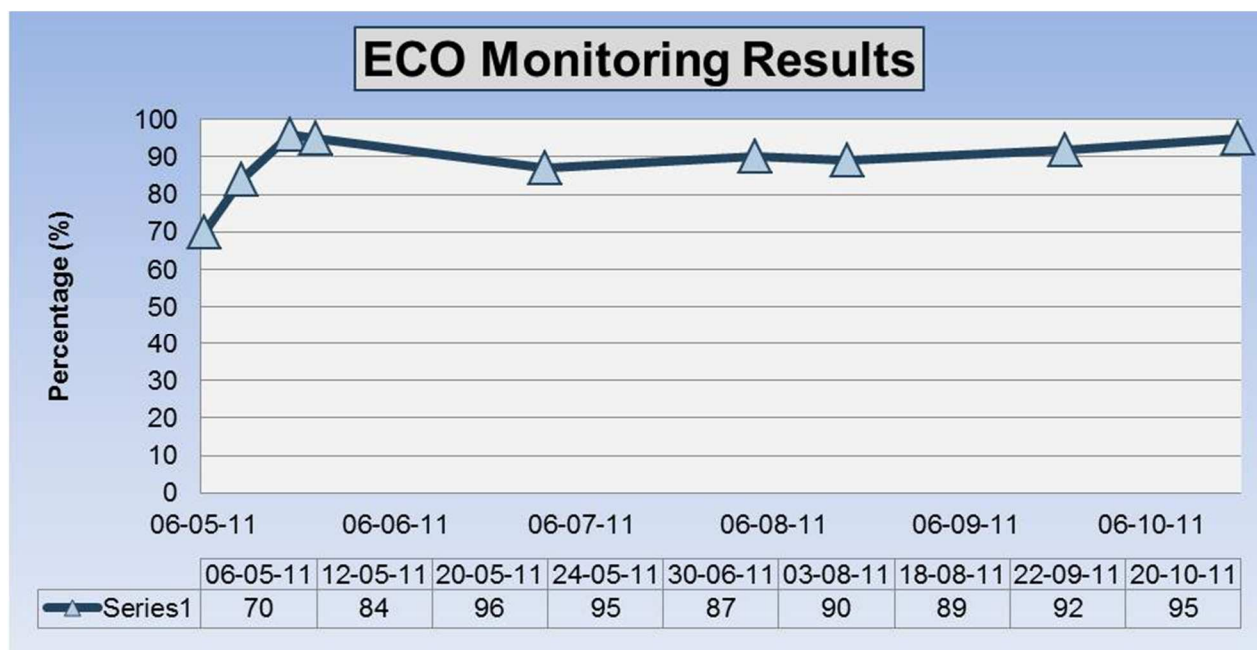
Figure 17: Graph - summary of results of Monthly ECO Monitoring Checklists

There was an improvement in the compliance score achieved from September 2011 to present.
