MOOI MGENI TRANSFER SCHEME PHASE 2 (MMTS-2)

Construction of the Spring Grove Dam & Appurtenant Works

MONTHLY ECO REPORT : December 2012

Report Title: **Monthly Environmental Control Officer Report**

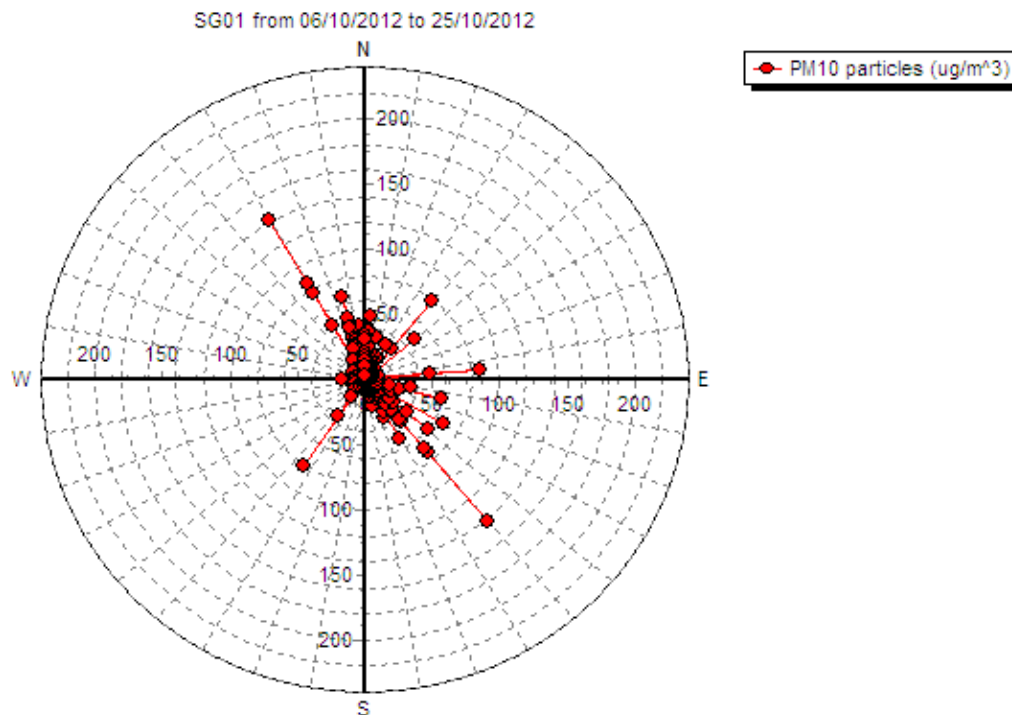
Figure 9: 1-hour PM₁₀ pollution rose for October 2012 at site SG01 (Blue Sands, 2012a)

- During October 2012, the PM₁₀ concentrations were fully compliant with the 24-hour limit of 120 $\mu\text{g}/\text{m}^3$.
- The pollution rose (see **Figure 9**) shows that the major contribution to the dust levels recorded came from the northerly sector. There are two sources in this area; one being the aggregate stock pile and the other being the parking area for the office block.
- Reviewing historical trends, it is interesting to note that the most dust either originates from the aggregate stockpiles (under windy conditions) or the road (under calm conditions).
