# MOOI MGENI TRANSFER SCHEME PHASE 2 (MMTS-2) Construction of the Spring Grove Dam & Appurtenant Works

## MONTHLY ECO REPORT : August 2012

*Report Title:* **Monthly Environmental Control Officer Report**

*Date of issue:* **21 August 2012**

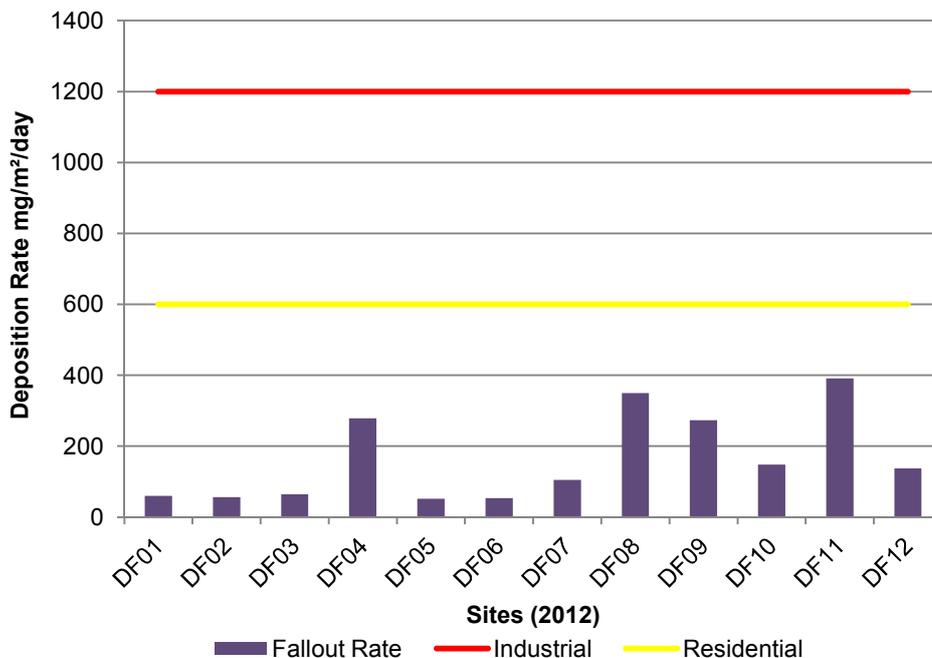
**Figure 12:** Dust fallout rates for June 2012 (Blue Sands, 2012a)

- Site DF12 is now located at Mpfana Outfall site (no longer at Mr John Wetton's Property), since 31 May 2012.
- Dry winter conditions noted.
- Dust fallout rates remained well within the residential band.
- Highest fallout rate measured at site D11 (Peter Warren's Property).

- Blue Sands (2012a) recommended that the Contractor will need to increase the frequency of the water cart irrigation if possible, or utilize additional carts to keep unpaved roads wet

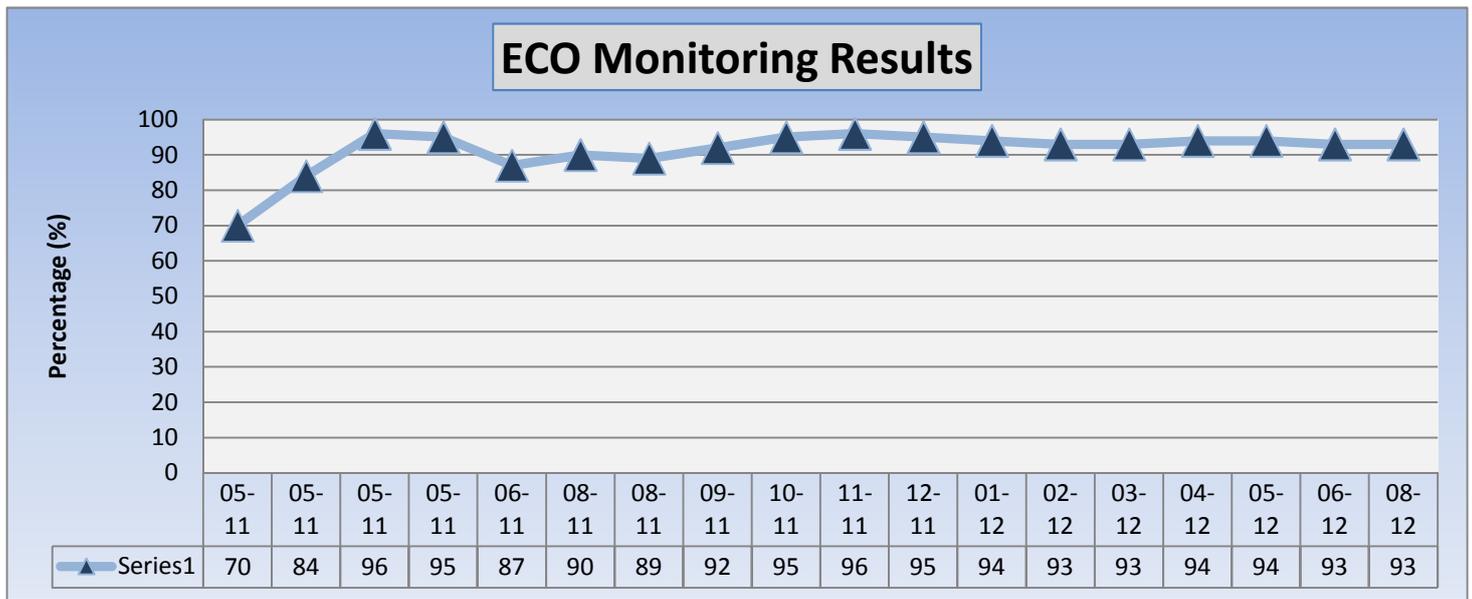
**Figure 20: Graph – summary of results of Monthly ECO Monitoring Checklists**

Although a high conformance score was achieved, those areas where non-compliance was noted need to be attended to as they are regarded as significant. Without the weighting of the scoring items, a full appreciation of the significance of the non-compliance is not conveyed.

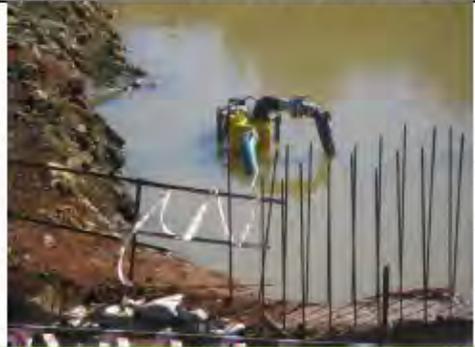
<p style="text-align: center;"><i>No Photo Taken</i></p>
<p>Fig 1: On 10 August 2012 (date of last weekly inspection) a diesel generator was submerged in the coffer dam of the gauging weir</p>	<p>During this inspection, this generator had been removed from the gauging weir construction area</p>

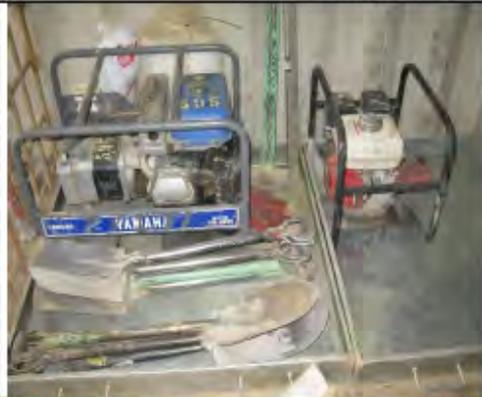
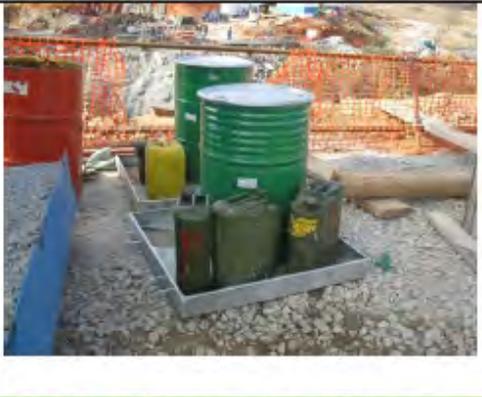
<p>Fig 1: Use of drip trays under diesel generators at left bank</p>	<p>Fig. 2: Use of drip tray under jerry cans and hazardous materials container on river diversion walkway</p>
